New Vanguard

Cadillac Gage V-100 Commando 1960-71

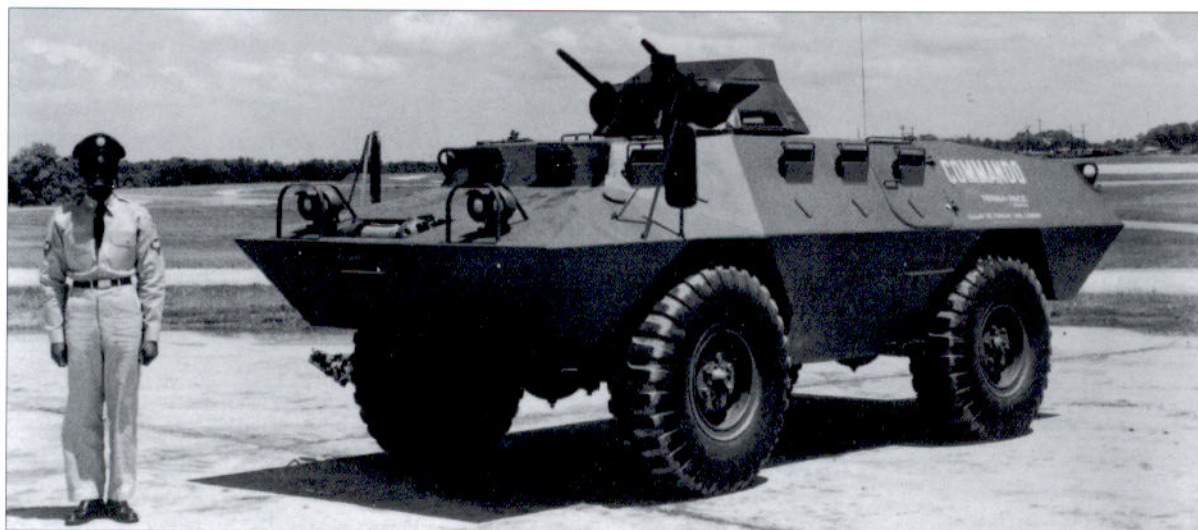
This photograph, which was taken at Aberdeen Proving Ground, shows one of the Commando prototypes with a soldier standing next to it for reference. The rear quarter panel has stenciled on it "Commando by Terra-Space Corporation." The original turret has now been replaced by a new design with guns mounted on the exterior edges of the vehicle.

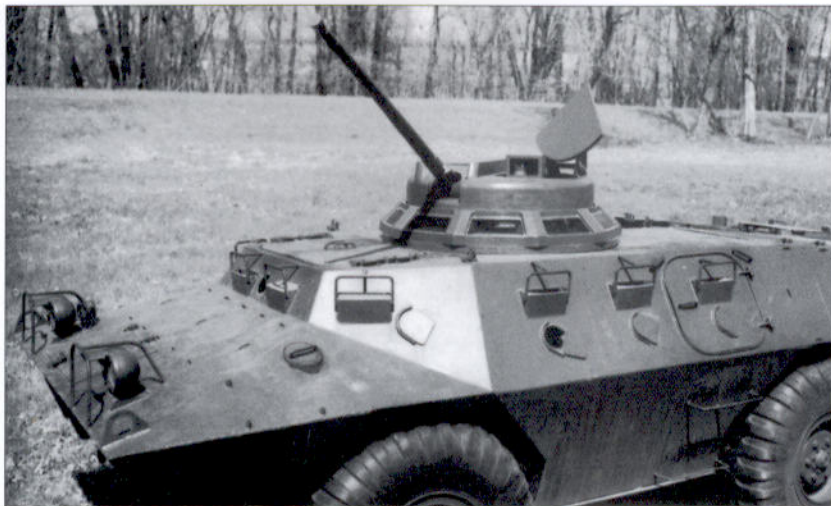
ABOVE One of the original prototypes fitted with a prototype 20mm turret at Rock Island Arsenal. The turret was never used, but experience led to the replacement of the periscopes with vision blocks.

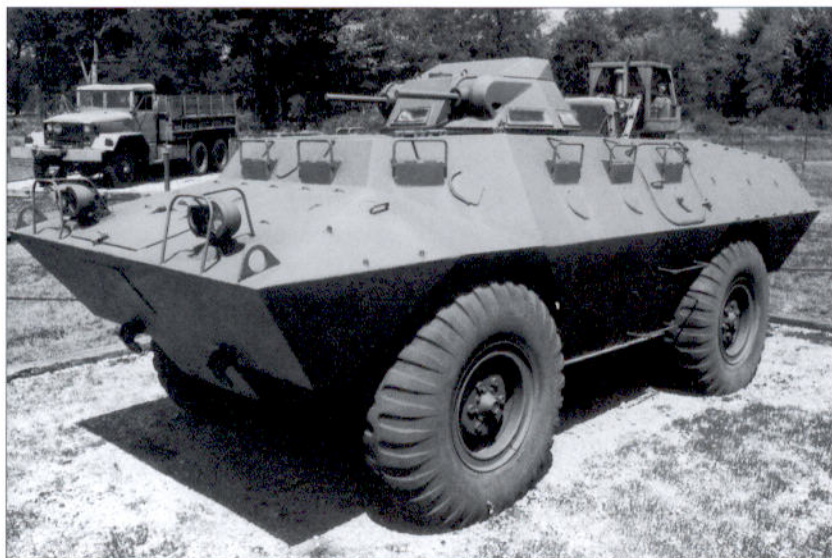
BELOW A front view of serial number 10002 located at Fort McCoy Museum. The locations for the periscopes, which are not fitted, are visible. The side door has now been added and the turret changed to mount the twin machine guns on the outer edges of the turret. The later Cadillac Gage 1m twin machine gun turret used the same arrangement for machine guns.

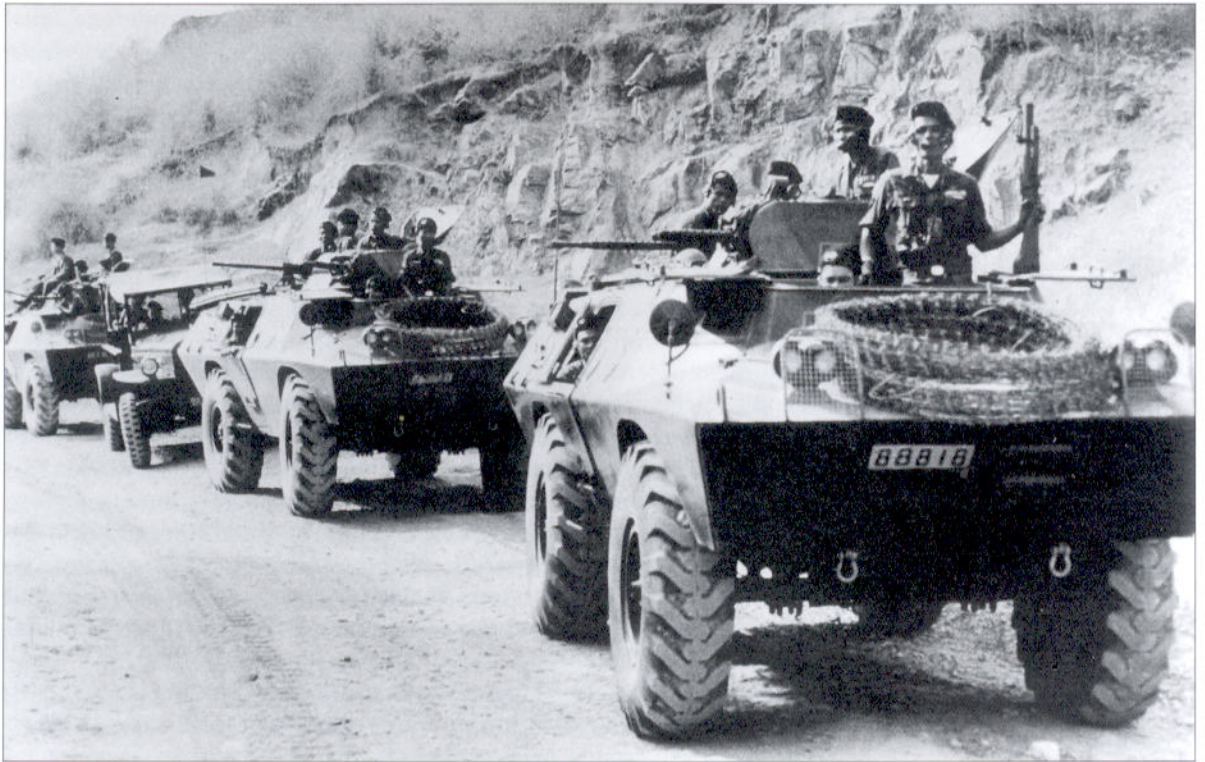
Three ARVN V-100s on patrol somewhere in South Vietnam. All the vehicles pictured have an M1919A4 machine gun mounted at the rear for additional firepower. The commander in the lead vehicle is carrying an M79 40mm grenade launcher. The truck pictured is an M601, which was a militarized export version of the WM-300 1-ton Dodge Power Wagon. (Copyright Cadillac Gage Textron Inc.)

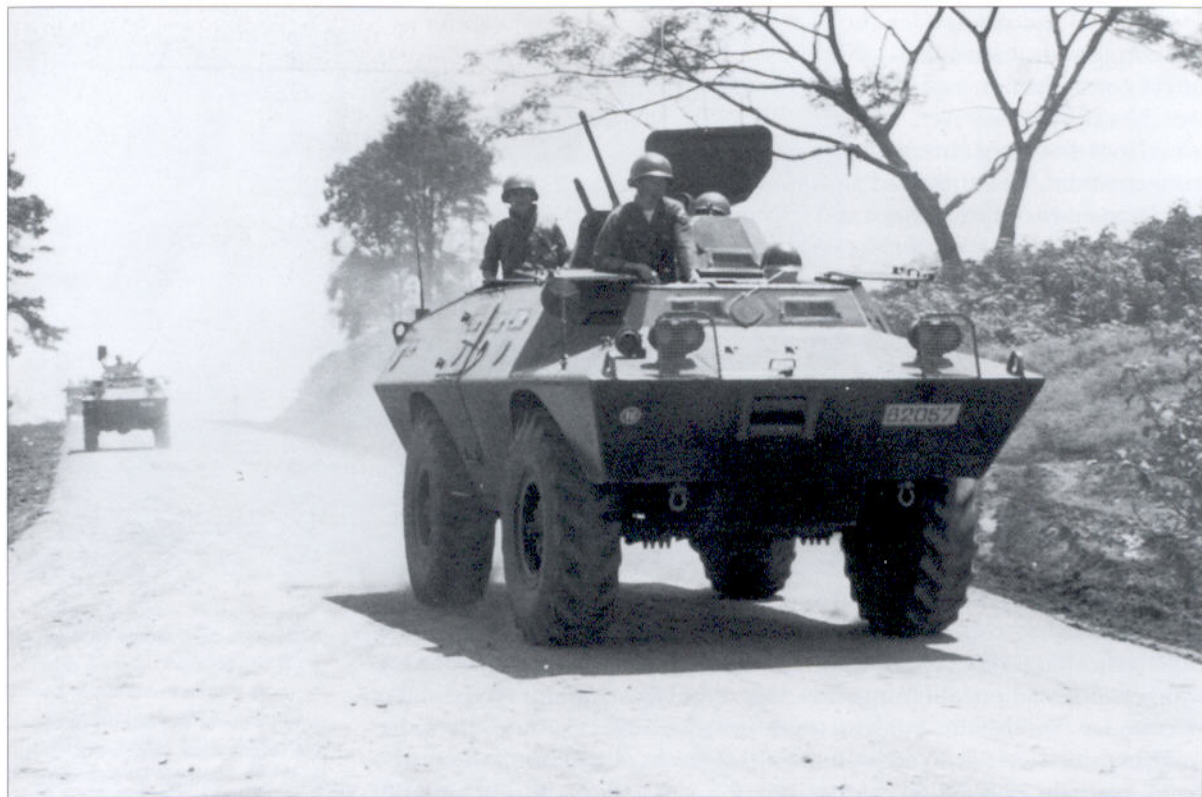
Two V-100s patrolling along a road. The yellow lettered "TC" within a red circle signifies that this is a V-100 belonging to an ARVN cavalry unit. These two V-100s are armed with a combination-mount, consisting of a .30 M37 or M1919A4 machine gun and a .50 M2 machine gun. (Copyright Cadillac Gage Textron Inc.)

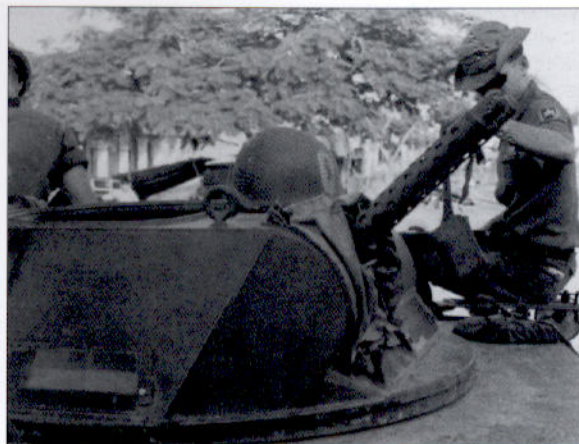
Detail of the twin M37 or M1919A4 .30-caliber machine guns mounted on the T-50 turret. This is a later turret, as the earlier models had a narrower vision block in the front to compensate for the width of the .30 M37/.50 M2 machine gun mount.

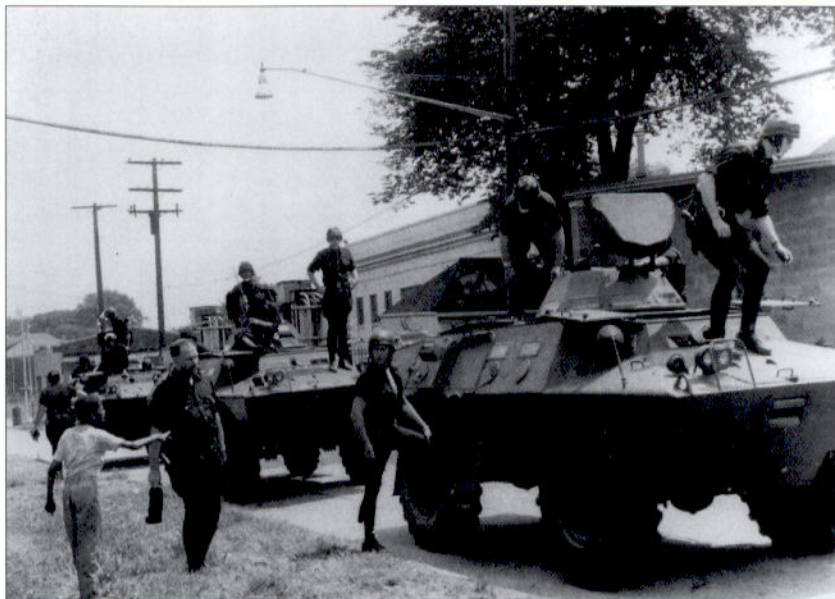
and 2nd tactical zones; and the 89th MP group, which controlled the MP units stationed in the south, the 3rd and 4th tactical zones. The purpose of the 18th Military Police Brigade was to create a better organization and to exercise control of the military police units in South Vietnam. Until the activation of the 18th Brigade, the independent military police units had been under the control of commanders of the four tactical zones in South Vietnam. At the height of the war, there were over 6,000 military policemen in Vietnam. The first large-scale operation of the 18th Brigade was providing convoy security and traffic control during Operation Deckhouse and Operation Attleboro in November 1966.

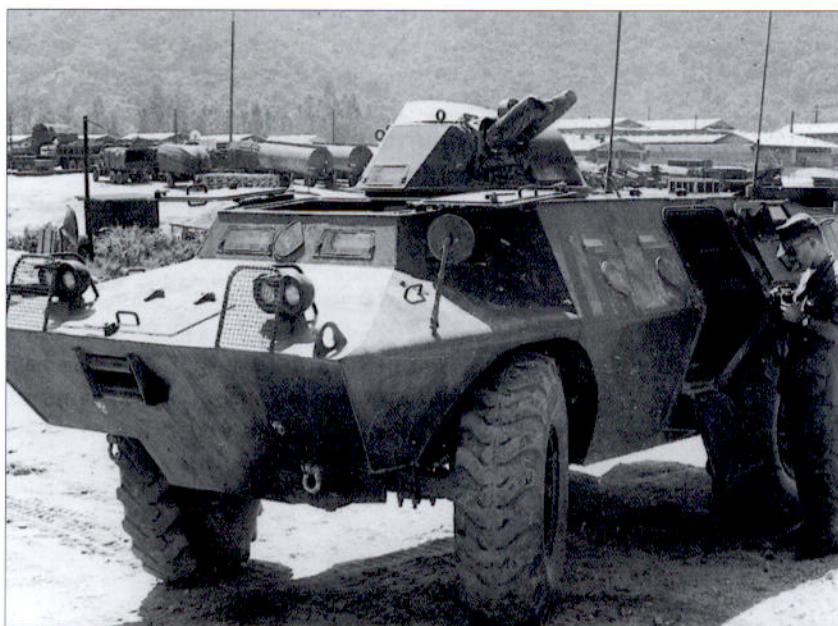
Military policemen of the 504th collect an early evaluation V-100 at a depot in Vietnam. Notice that 18th Military Police emblems have been painted on the front of the vehicle.

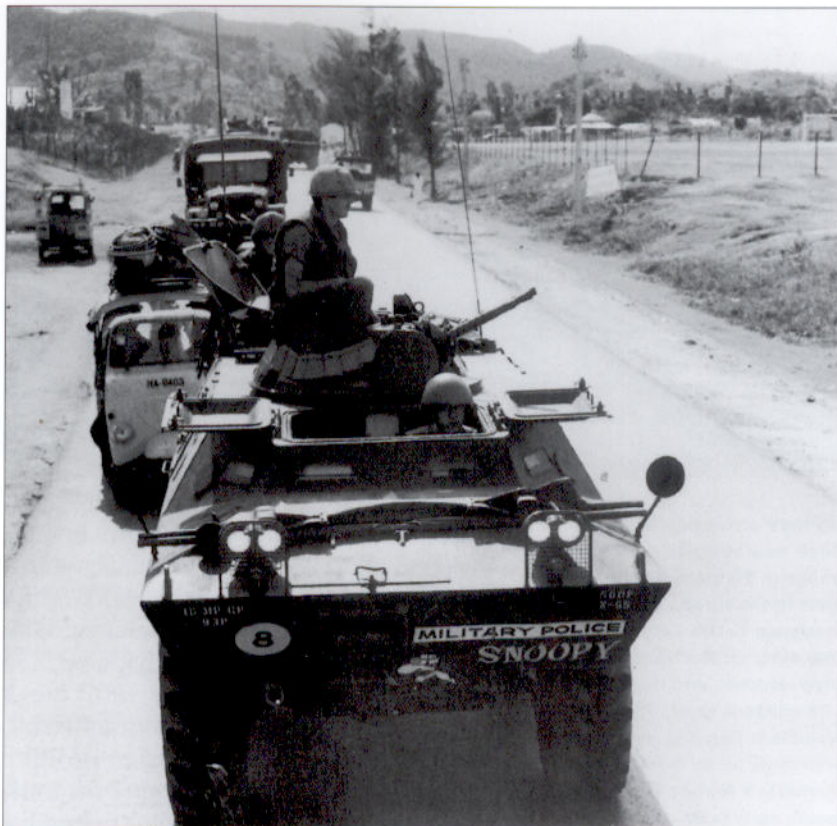
"Snoopy", a V-100 of the 560th MPs maintains watch while escorting a convoy. This is a later production V-100, a fact evidenced by the raised hatches. The gunner has attached a bandolier of M16 magazines around the exterior of the vehicle. Artwork of Snoopy flying his trademark doghouse in an MP's helmet is clearly visible. Notice that the crew are each wearing a different helmet. The driver wears a combat vehicle crewman's helmet, the gunner the standard US Army helmet with cover, and the rear radio operator wears a helicopter pilot's helmet. The helicopter helmet was popular with crews as it combined the helmet, headset, and microphone into one unit, along with a visor to protect the eyes.

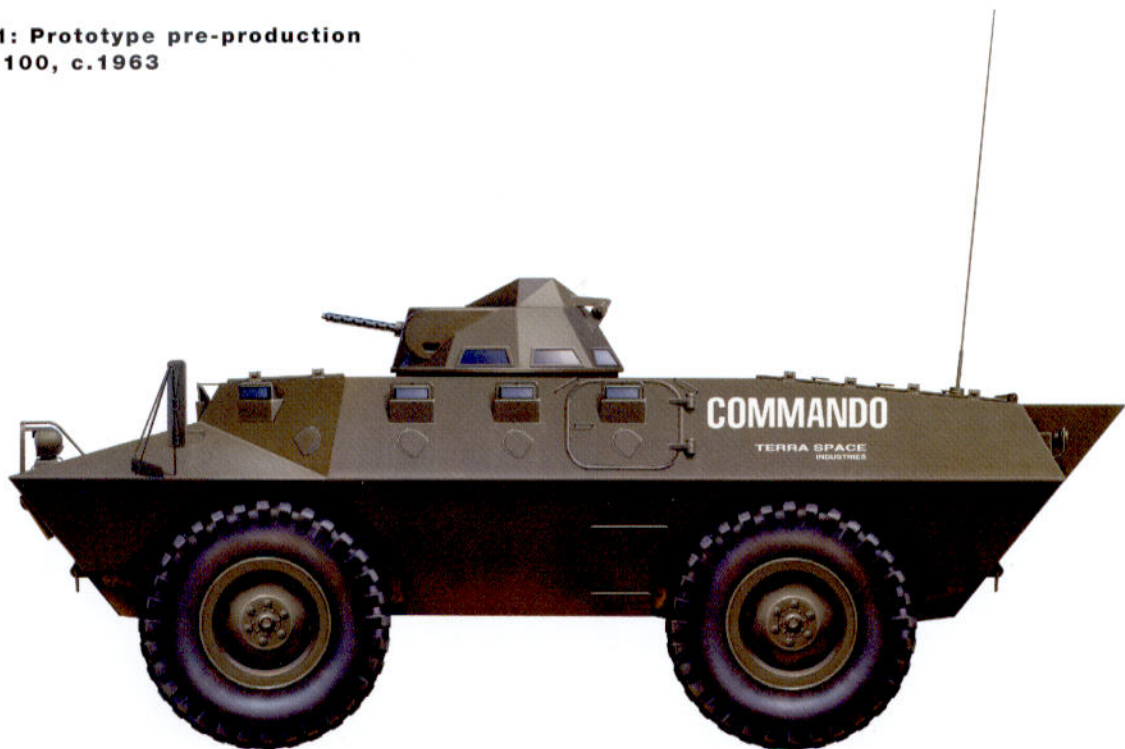
**A2: Early-production V-100
(XM706), c.1966**

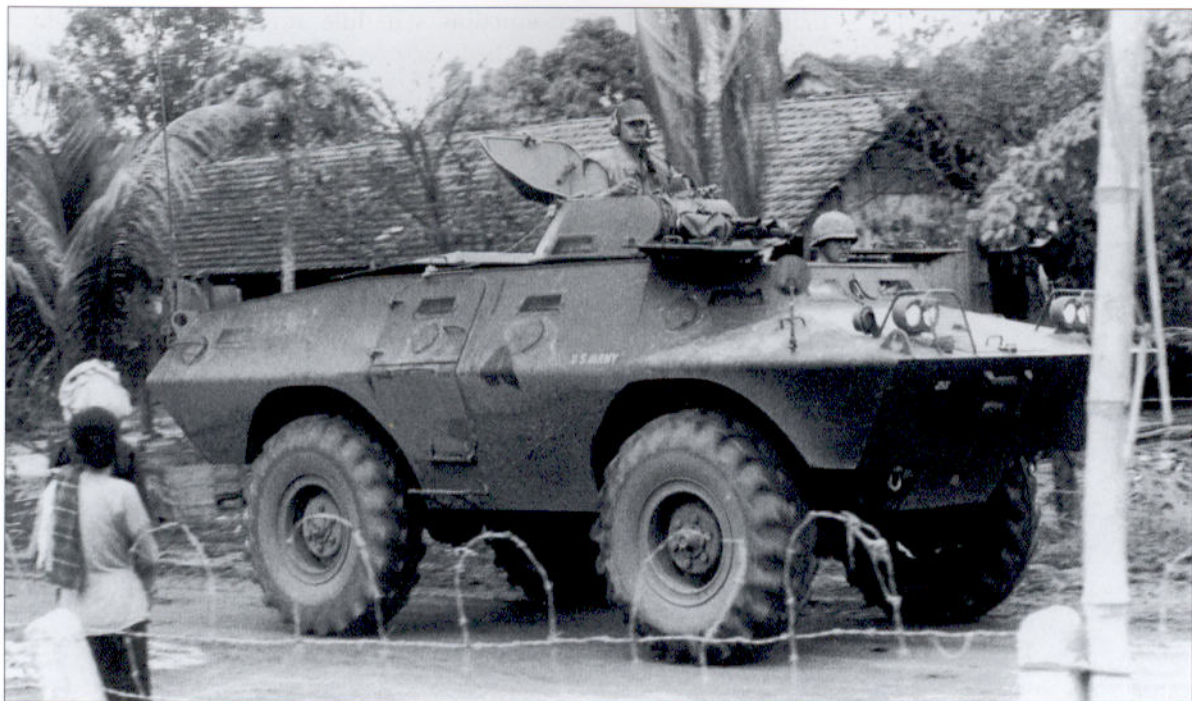
An unidentified US V-100 rolls through Ap Ninh Hung as part of a convoy. The antenna cable has been routed out of the radio operator's gun port to form a makeshift antenna mount on the rear of the vehicle.

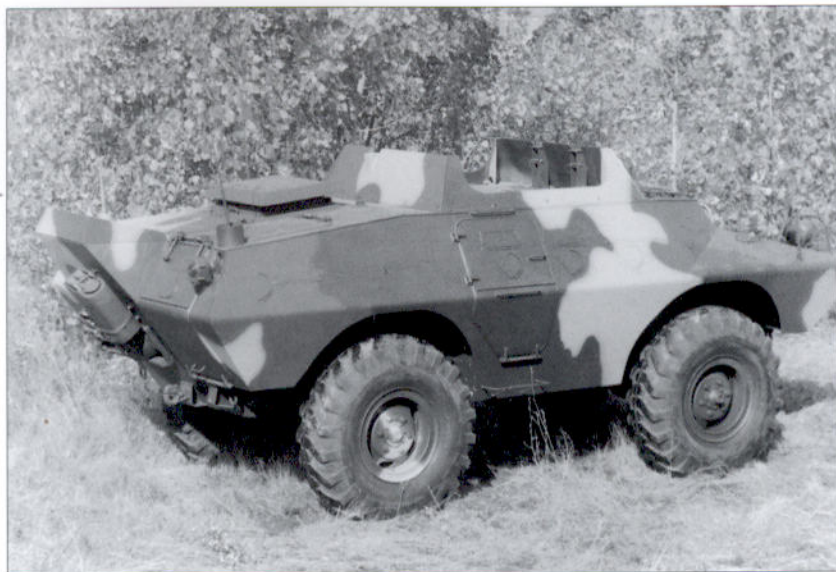
A freshly painted US Air Force V-100 illustrated against a woodland backdrop. USAF V-100s served as a mobile strongpoint and arms carrier for responding to intrusions and enemy attacks on air bases in Vietnam and Thailand. (Copyright Cadillac Gage Textron Inc.)

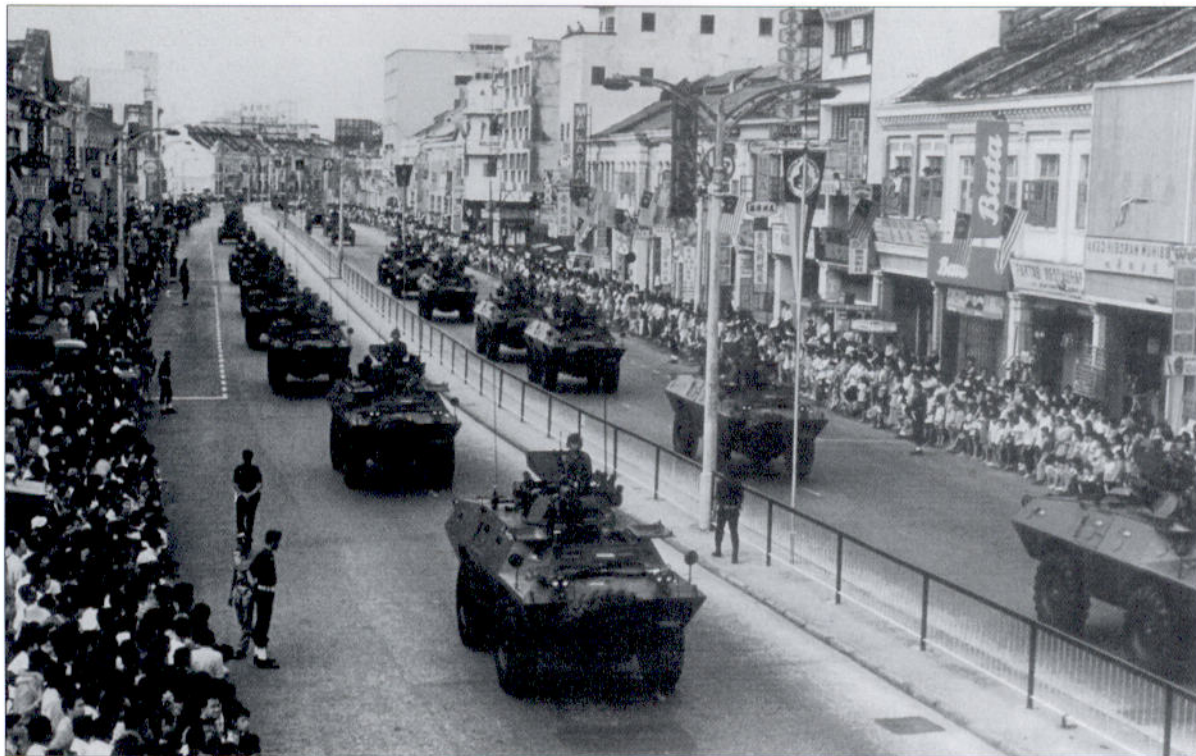
COLOR PLATE COMMENTARY

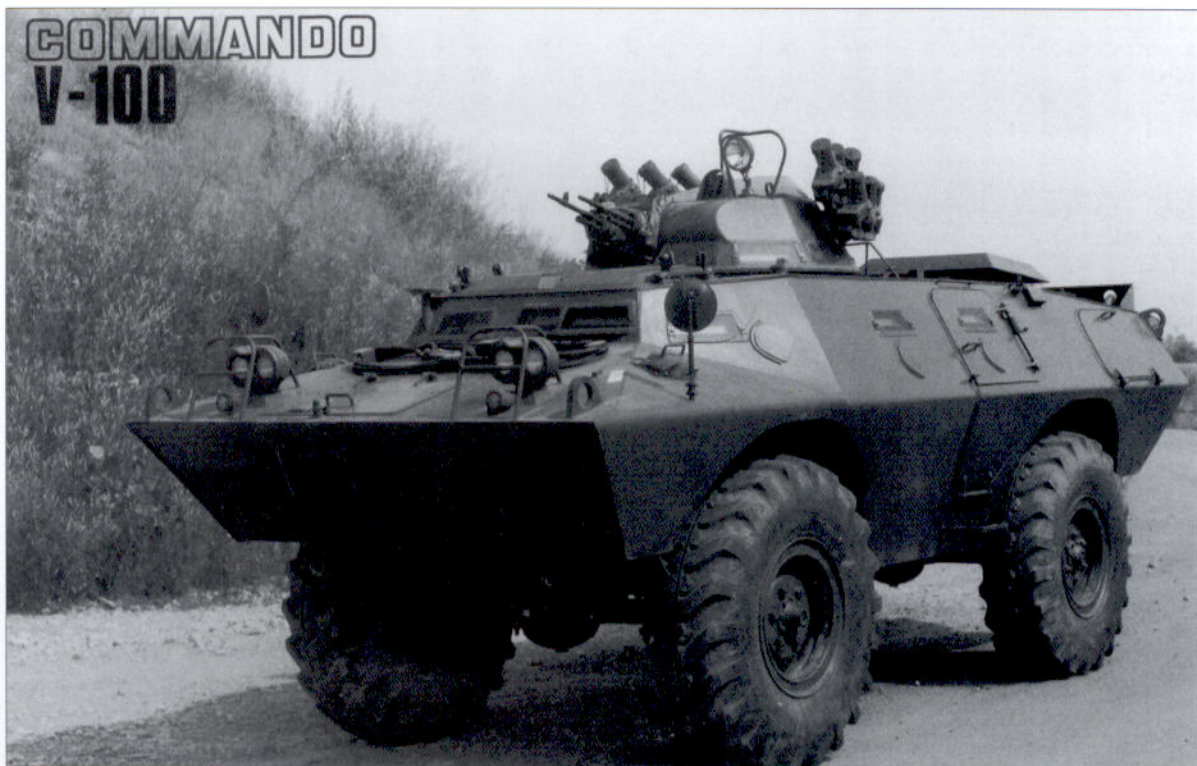
C2: MID-PRODUCTION V-100 WITH GRENADE LAUNCHER TURRET (XM706E1)
