# Panther Medium Tank 1942–45

Stephen A Hart • Illustrated by Jim Laurier

New Vanguard • 67

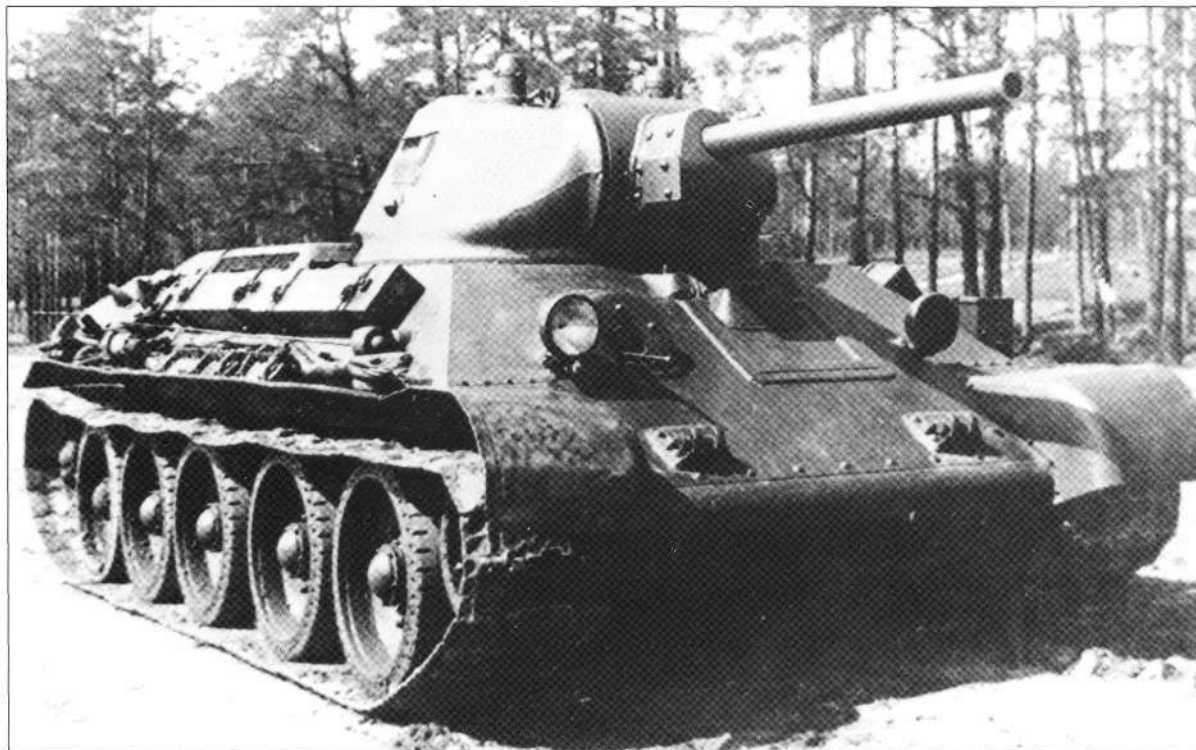
**The shock the Germans experienced after encountering the Soviet T-34/76 tank during Operation Barbarossa led them to develop the Panther, which incorporated the overhanging gun barrel, well-sloped armoured plates, and large road wheels featured in the enemy tank. (The Tank Museum, 47/E6)**

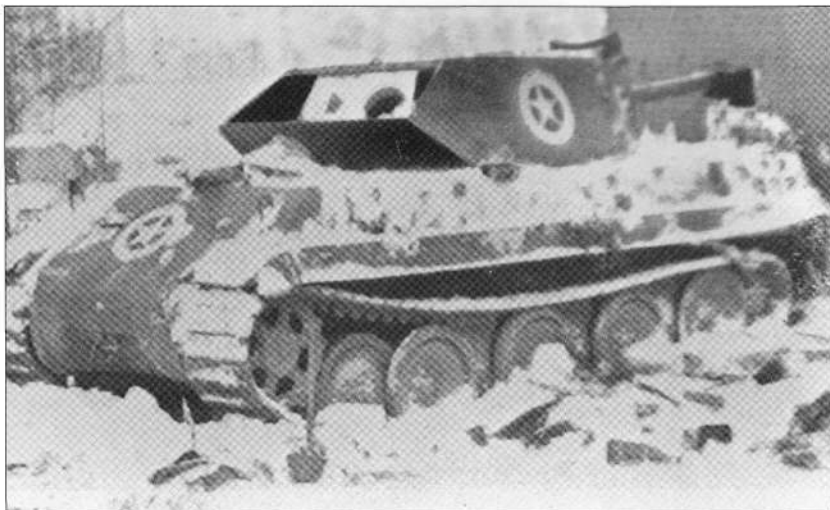
**ABOVE** The 150th Panzer Brigade employed 10 Panthers disguised as American M10 tank destroyers to spread confusion during the initial stages of the mid-December 1944 German Ardennes counter-offensive. (The Tank Museum, 1164/A2)

As a postscript to the role played by Model G tanks in the Ardennes, a unique Panther mission should be mentioned. The Germans attempted to compensate for their lack of combat power by employing surprise and confusion as a force multiplier. On 16 December, Dietrich committed SS Colonel Otto Skorzeny's 150th Panzer Brigade to a covert operation. The brigade fielded 10 modified 'Ersatz' Panthers that had been cleverly disguised to resemble American M-10 tank destroyers. Backed by these vehicles, Skorzeny's commandos – some dressed as American military police – infiltrated the American lines to misdirect

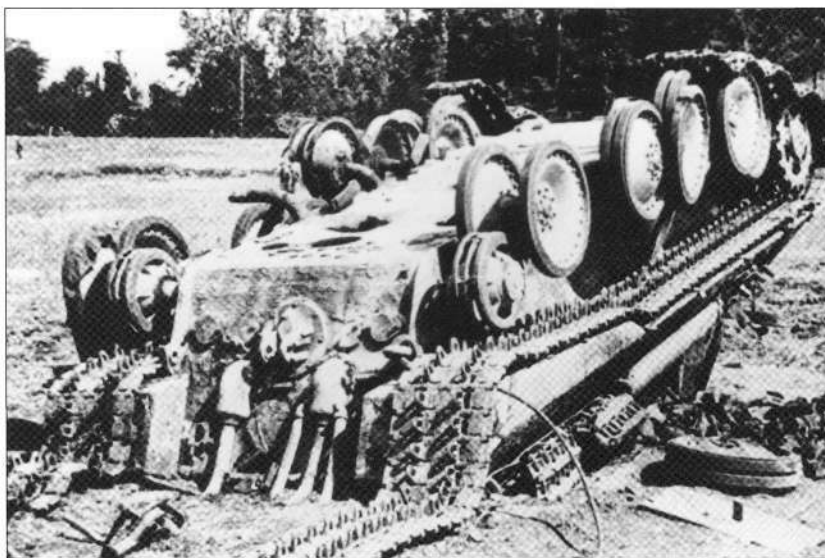
**BELOW** This mid-production Model A Panther has been overturned, presumably by Allied aerial bombing, at Norrey-en-Bessin during the summer 1944 Normandy campaign. Note the twin cooling pipes added to the vehicle's left exhaust pipe. (The Tank Museum, 5721/F6)

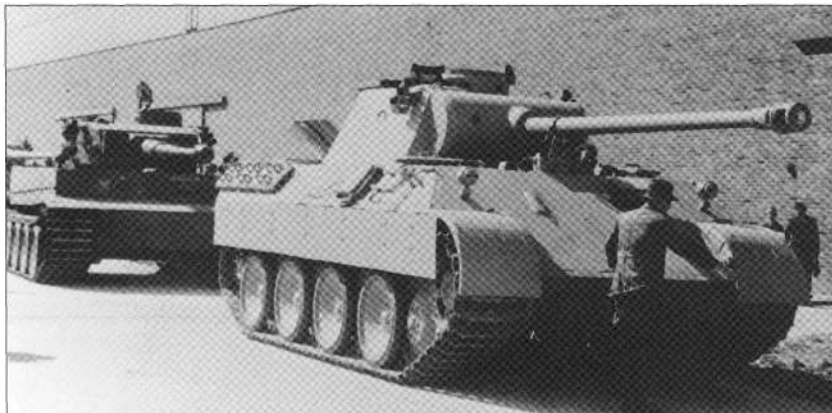
**This early Model D Panther, completed by Henschel in early May 1943, sports smoke-grenade launchers, a feature discontinued in Panthers completed after early June. Note the Henschel-produced Tiger in the background. (The Tank Museum, 6087/D2)**

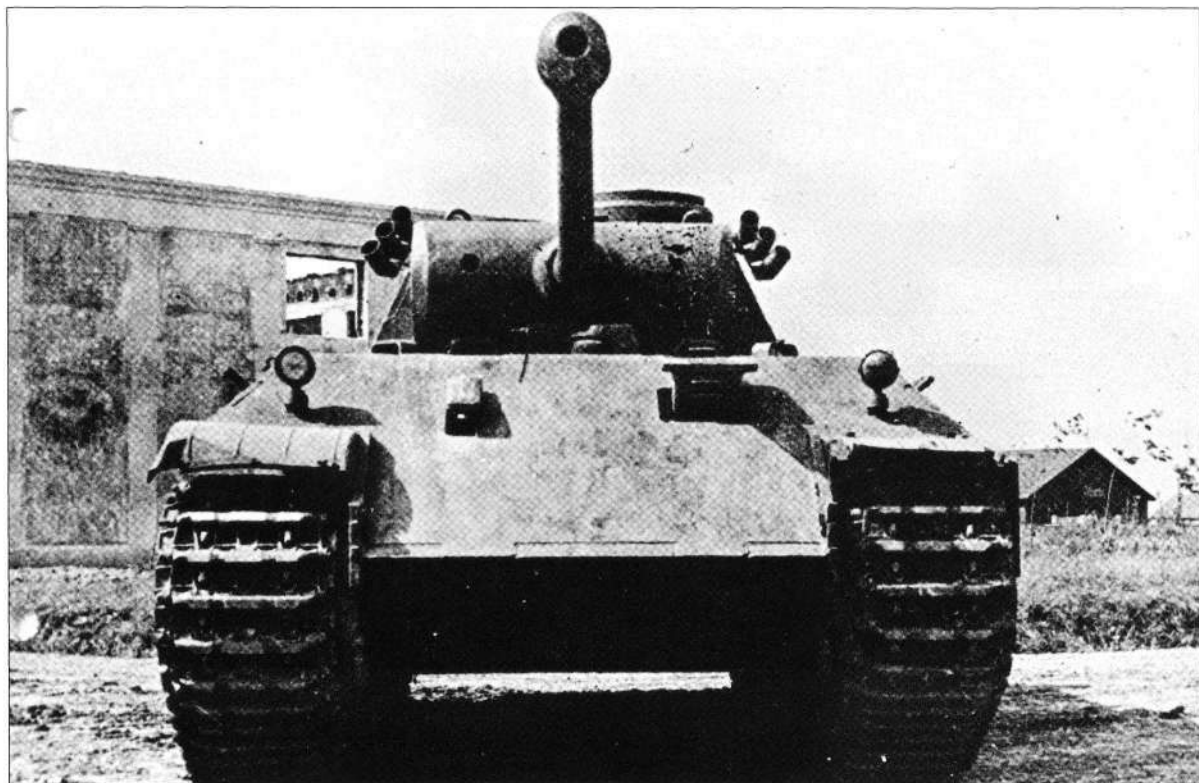
**This early Model D Panther sports two features that distinguish it from later Model D tanks – its smoke-grenade launchers and the two shrouded lamps located on the hull glacis plate. Two features characteristic of Model D or early Model A Panthers are also evident – the tall letterbox machine gun mount on the right glacis plate and the oblong driver's visor on the left glacis plate. (The Tank Museum, 22/C2)**

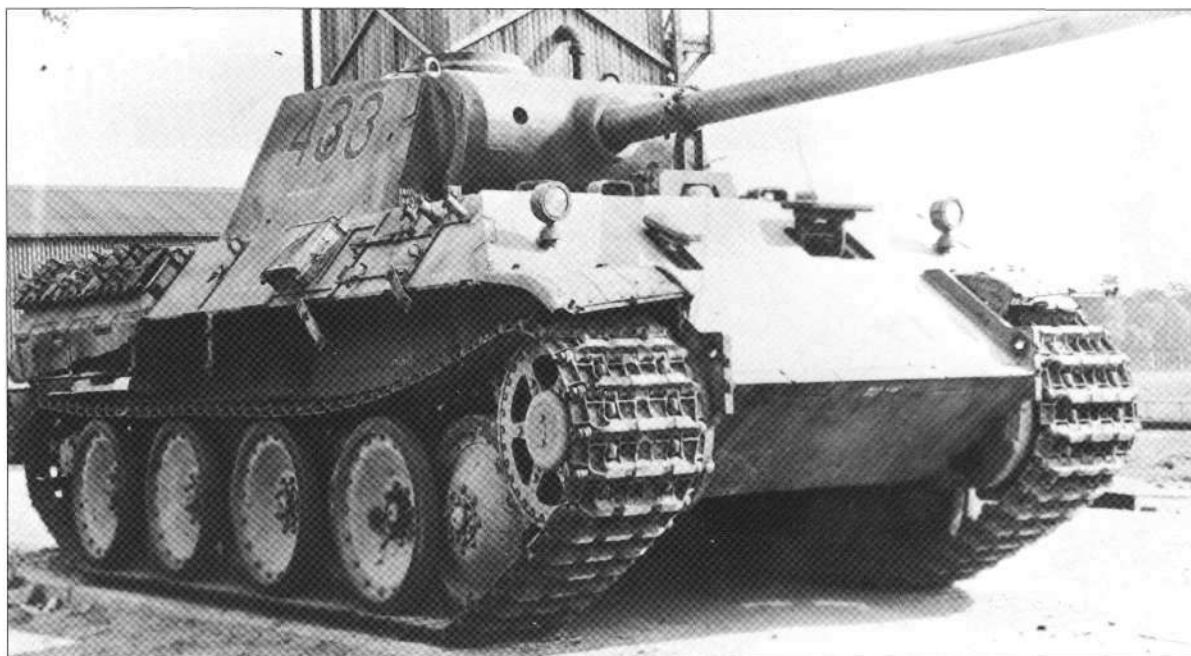
**The mid-production Model D Panther chassis number 213101, completed by MNH in late May or early June 1943, lacked smoke-grenade launchers but sported the more powerful 700bhp engine. This tank fought at Kursk where the Soviets captured it and then sent it to Britain, where this picture was taken. (The Tank Museum, 2389/D4)**

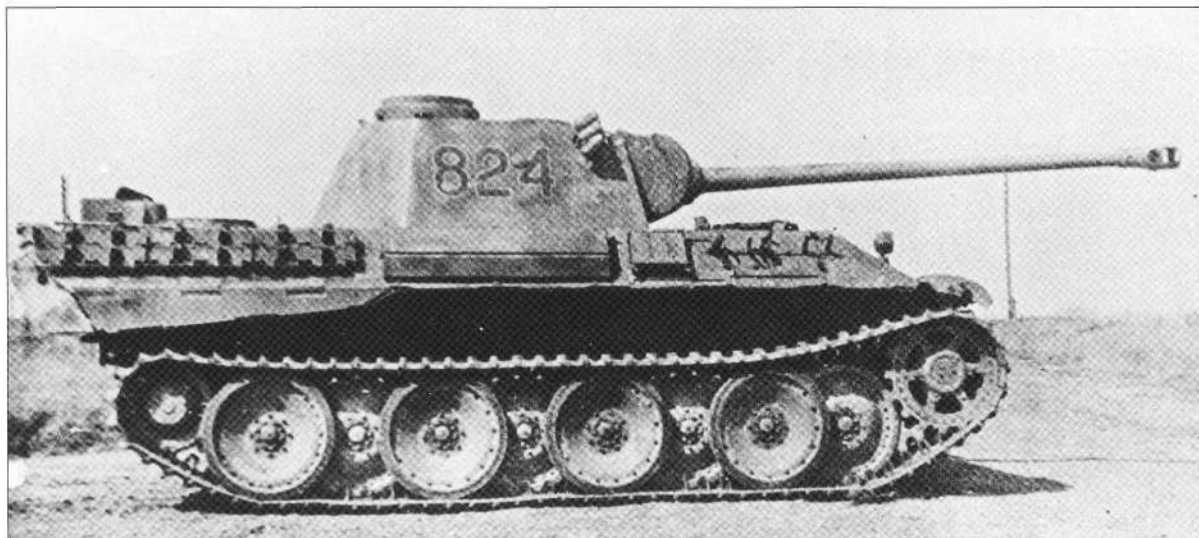
**This early Model D Panther fought in Operation Citadel during July 1943. Its tactical designation, painted in red with a white outline, identifies it as the fourth vehicle of the second platoon of the eighth company in one of the two Panther battalions employed in the offensive. (The Tank Museum, 22/B6)**

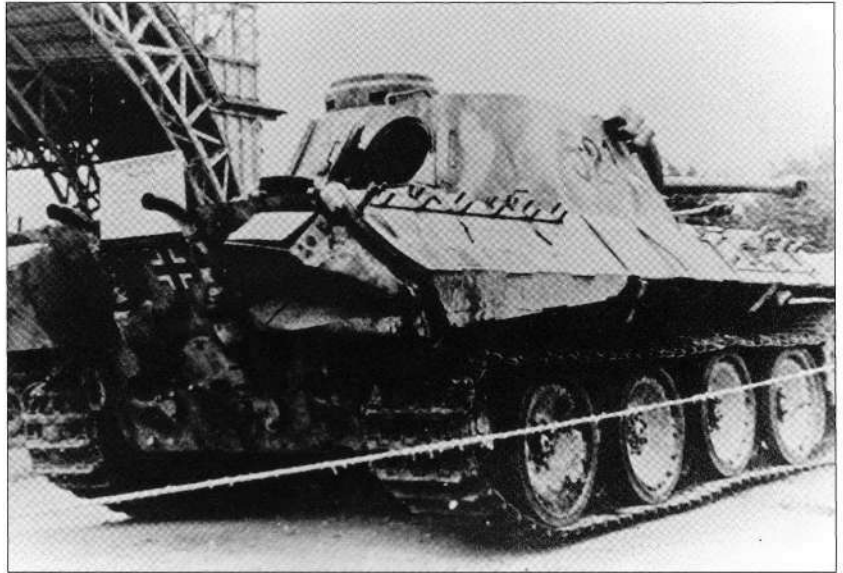
**The Soviets captured this early Model D Panther of the 51st Panzer Battalion during the abortive July 1943 German Citadel offensive. Hitler expected that the 200 Panthers deployed for the attack would prove decisive, but in reality the Panther's combat debut was disappointing. (The Tank Museum, 143/C5)**

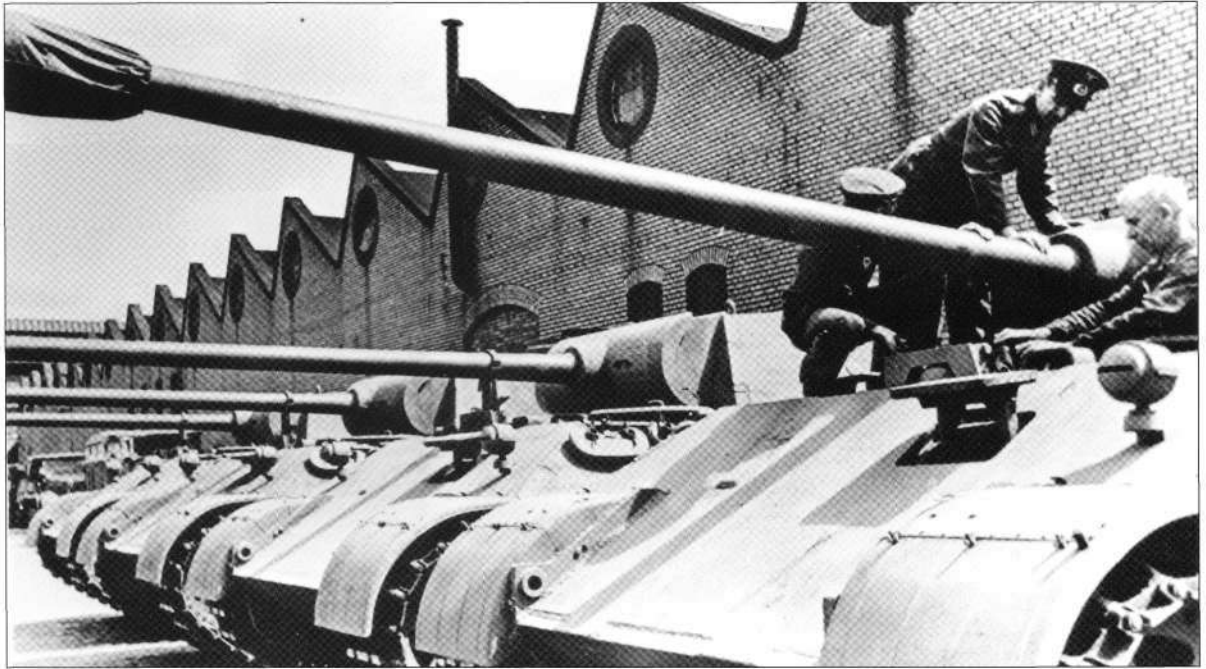
**These five Panthers include one mid-production Model D vehicle (nearest the camera) that sports one shrouded head light, and four earlier Model D tanks each with two such lights. The factories deleted the second lamp from July 1943 as an economy measure. (The Tank Museum, 2902/D4)**

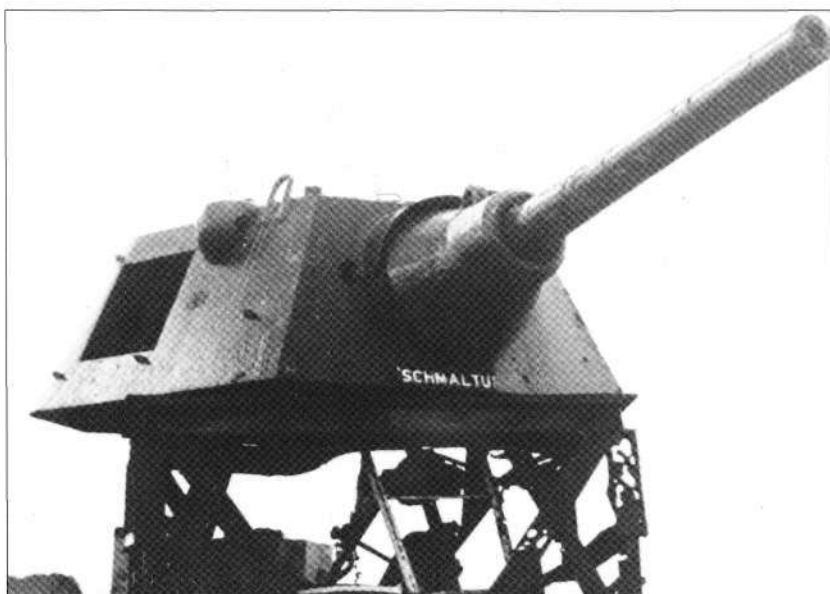
**The Germans intended to mount the Narrow Turret (Schmalturm), seen here in England during 1970, in the Panther Model F. Walther Spielberger contends that they also considered mounting the Schmalturm – rather than the Narrow Gun Mantlet Turret suggested by Tom Jentz – in the proposed Panther II. (The Tank Museum, 43/E2)**

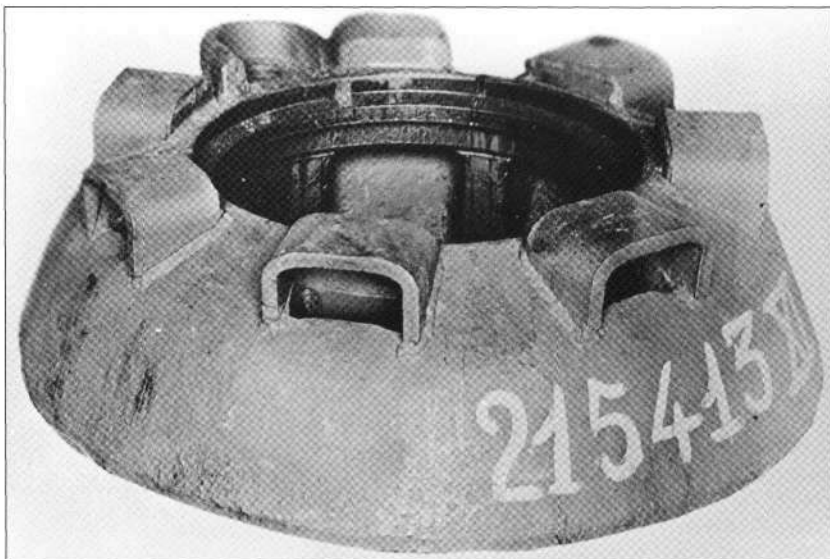
**The redesigned hemispherical commander's cupola of the Model A Panther, which contrasted with the drum-shaped version on the Model D tank, included seven periscopes protected by armoured cowlings that improved the field of vision obtained from within the turret. (The Tank Museum, 5/C2)**

armoured, hemispherical cast commander's cupola as opposed to the drum-shaped cupola of the Model D. The redesigned cupola had seven periscopes protected by armoured cowlings that improved the commander's field of vision, as well as an integral ring for affixing an anti-aircraft machine gun. Another externally visible difference between the two turrets was that on the Model A turret a squared-off joint fitted the turret front plate to the side plates, whereas on the Model D this joint was dove-tailed. In addition to external differences, the Model A turret had a redesigned interior that featured a new variable-speed hydraulic turret traversing system instead of the single-speed one fitted in the Model D. This mechanism produced a turret rotation time of between 15 and 93 seconds, depending on the speed of the engine and the traverse speed ratio selected. In addition, the redesigned turret also had a new bore evacuator that cleared powder gases out of the gun more efficiently than its predecessor.

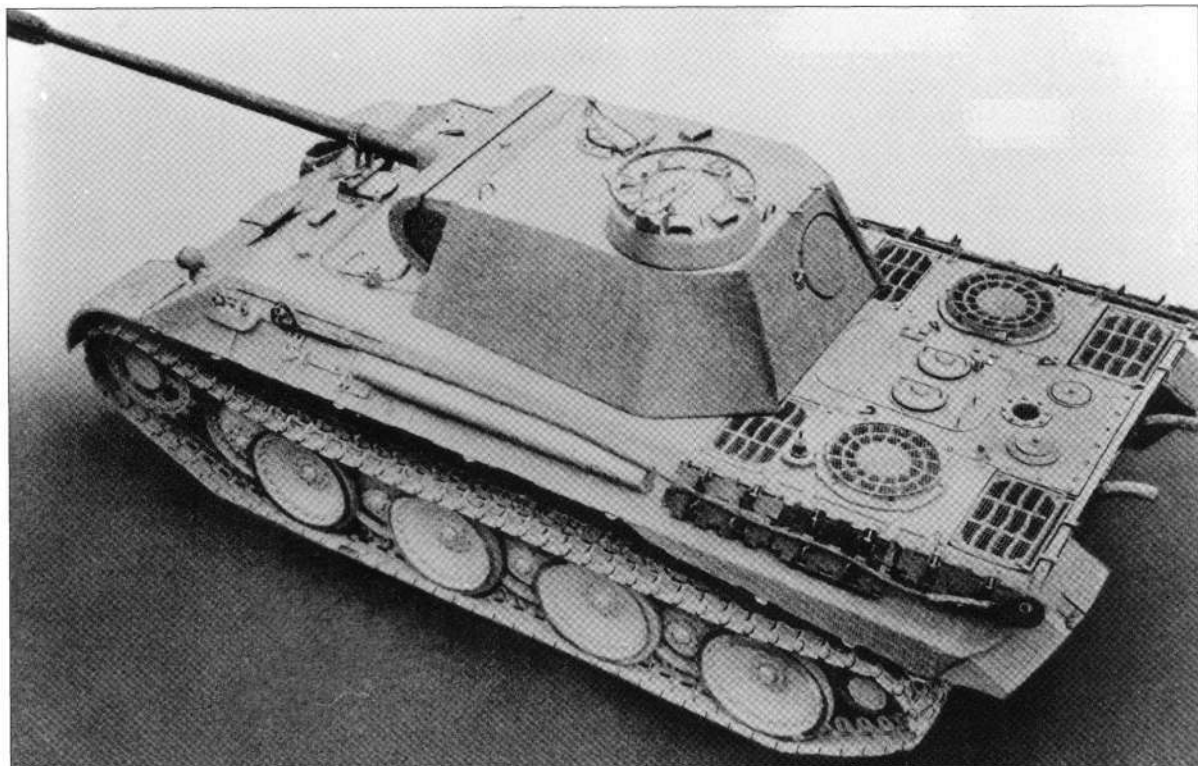
**This mid-production Model A Panther, seen at MAN's Nuremberg factory in January 1944, has 24 rim bolts on its road wheels (rather than the 16 bolts seen on most Model D tanks), and radial-pattern fan louvers on the hull rear decking (instead of the spiral ones mounted on early Model D tanks). (The Tank Museum, 2388/E6)**

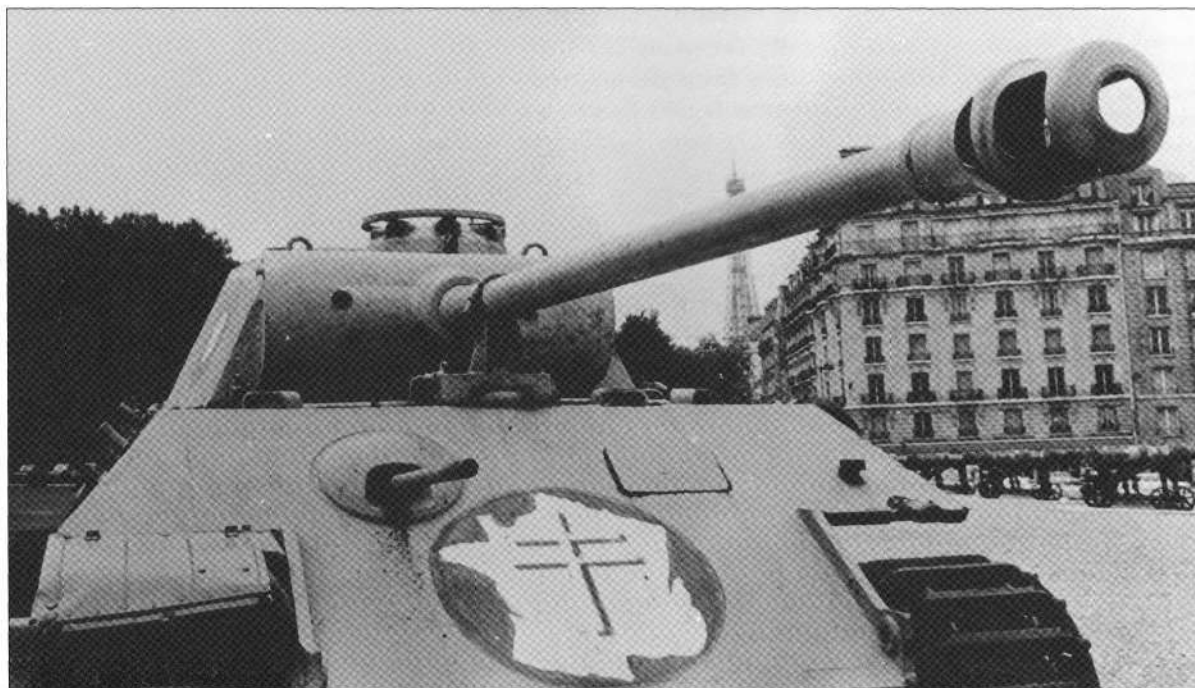
**French forces pressed into service this captured mid-production Model A Panther, identified by the Kugelblende 50 ball mount in the right hull glacis plate, but only after fitting a new machine gun into the mount – the Panther's MG 34 did not project so far beyond the glacis. (The Tank Museum, 2390/D1)**

From December 1943, new Model A tanks also began to appear with an externally obvious modification – the machine gun port in the glacis plate was replaced with a Kugelblende 50 ball-mounted weapon that enjoyed a greater field of fire. This mount included a KZF 2 sight for the radio operator, which meant that the operator's periscope sight on the hull roof could be dispensed with. The vehicles also had their binocular TFZ 12 telescopic gun sight in the turret mantlet replaced with the

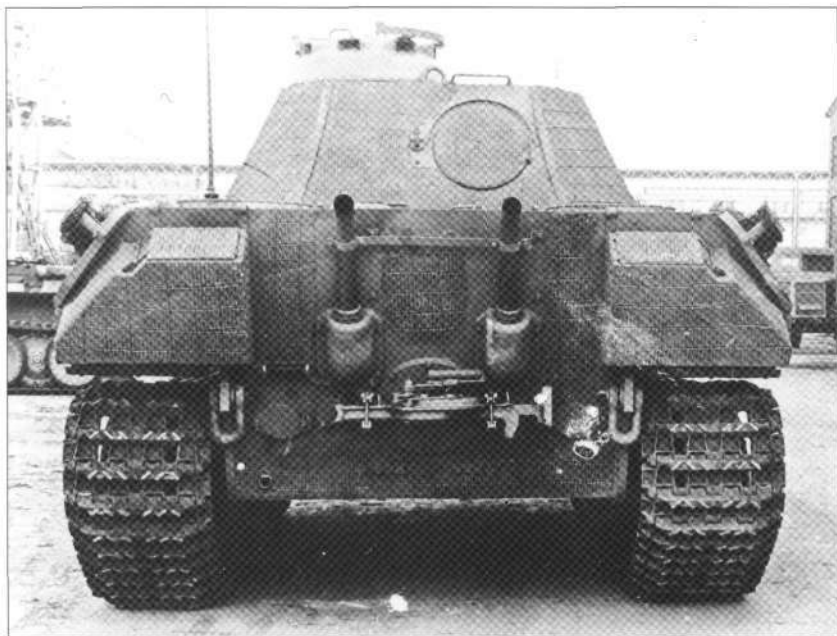
**On this early Model A Panther can be seen the initial layout of the vehicle's rear, with two exhaust pipes and the lack of a jack mounted between them. Note also the two large stowage bins fitted at the sides of the rear plate, a feature common to all Panthers. (The Tank Museum, 2388/F1)**

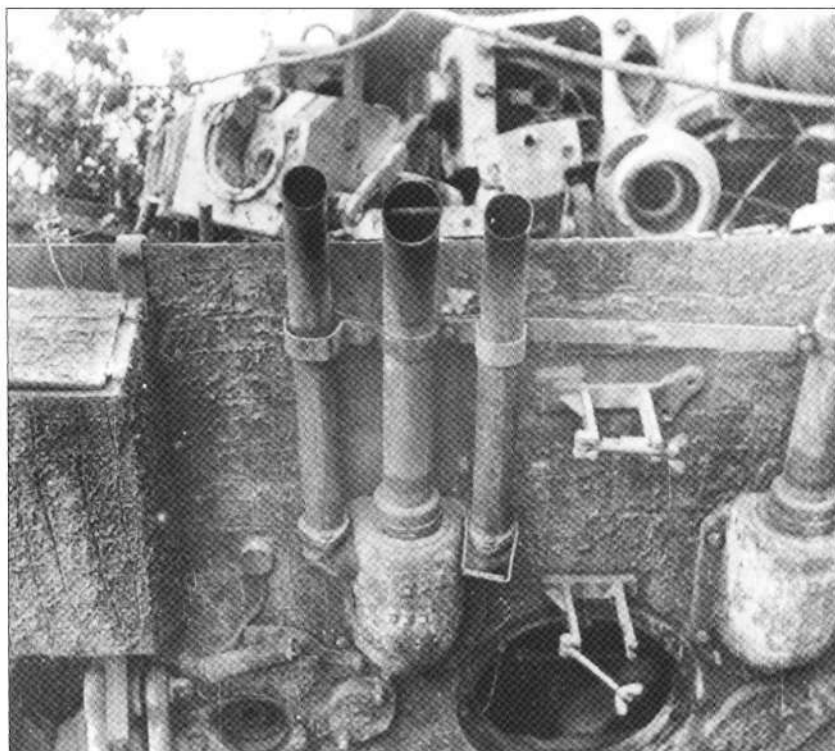
**This mid-production Model A Panther shows the two cooling pipes fitted to the left exhaust pipe in vehicles completed after early January 1944, as well as the jack mounted between the exhaust pipes. (The Tank Museum, 2902/E5)**

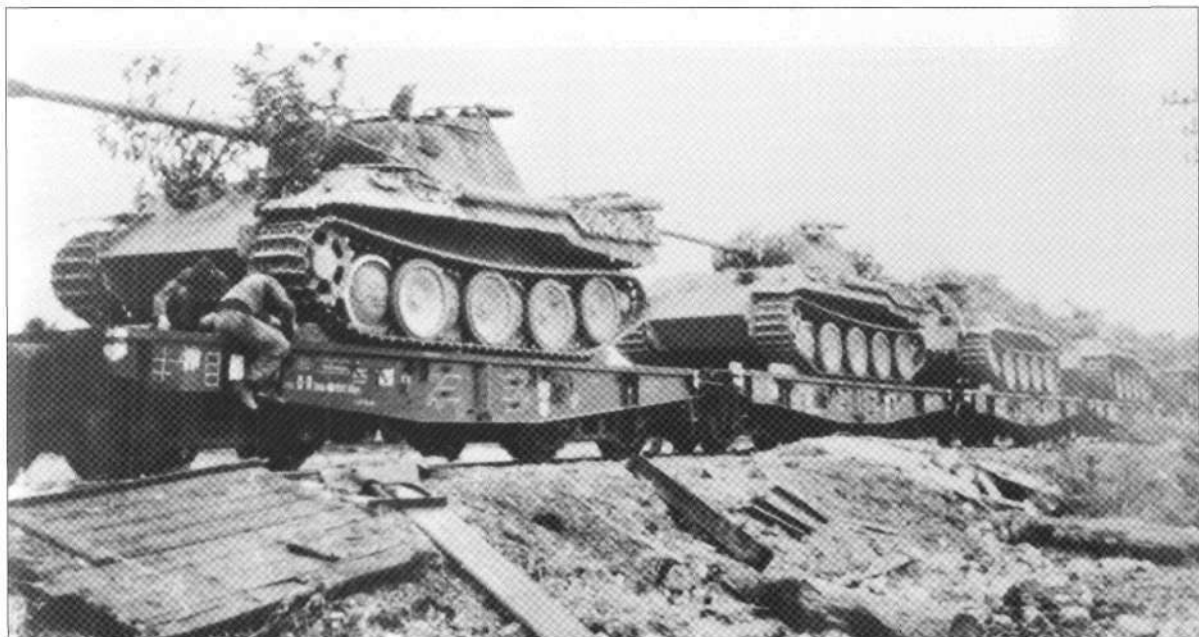
**Mid-production Model A Panthers being transported by rail to the East in early 1944. The crew of the lead tank have fitted spare track sections to the vehicle's rear hull sides, although increasingly crews mounted these sections on the tank's turret sides to further protect this crucial part of the vehicle. (The Tank Museum, 4704/C4)**

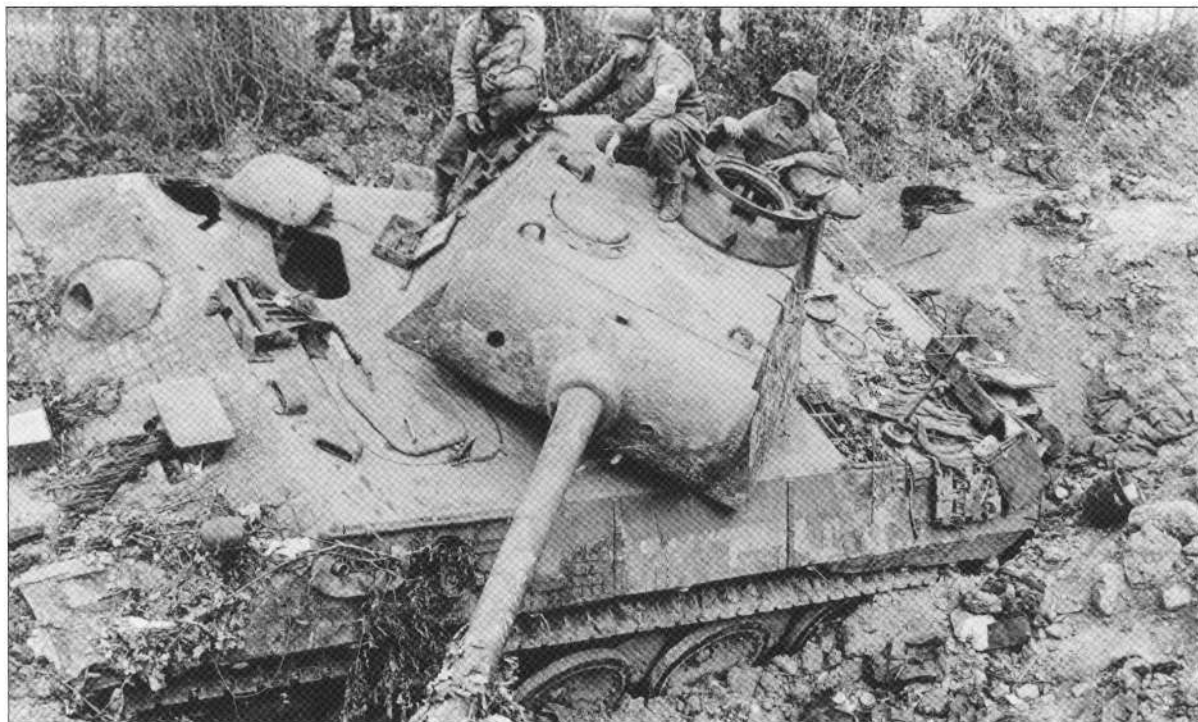
**Aerial bombing knocked out this Model A Panther at Canisy, near St Lô, in late July 1944, during the American Cobra offensive. Panthers of the SS Das Reich Division, including that led by Barkmann, attempted in vain to halt this successful offensive. (The Tank Museum, 561/A2)**

On 27 July 1944, Barkmann's tank found itself cut off from the rest of the division by the rapid advances achieved by the American Cobra offensive. During that day, Barkmann's by now damaged Panther nonetheless managed to knock out nine Shermans in a famous break-out attempt now known as the battle of Barkmann's Corner, and the next day he successfully rejoined his parent formation near Coutances. In the bitter defensive stands that raged over the next two days Barkmann accounted for another 15 Allied tanks before having to abandon his burning tank on 30 July. His crew nevertheless managed to escape on foot to fight another day. Re-equipped with a new Model G tank, Barkmann would go on to add further 'kills' to his personal tally during the mid-December 1944 German Ardennes counter-offensive. Although destruction or abandonment was the fate of most remaining Model A tanks during winter 1944–45, it remains clear that small numbers of Model A Panthers that somehow had managed to survive over a year of front-line service continued to offer fierce resistance to the Allied advance right up to the very last days of the war.

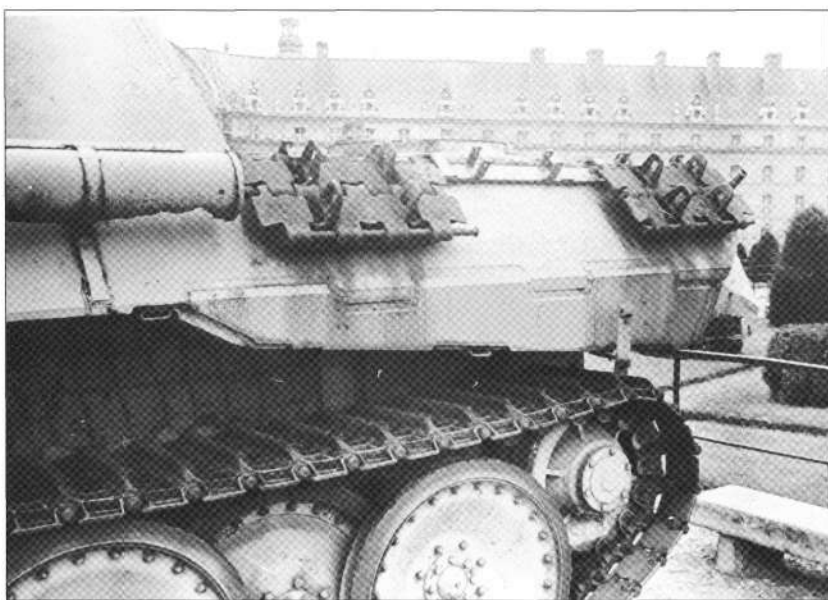
The distinctive 'wedge' found on the bottom of the hull sides at the vehicle's rear was a characteristic of both Model D and Model A Panthers. However, the Model G variant deleted this wedge in favour of a straight but tapering hull side bottom edge. (The Tank Museum, 2390/B3)

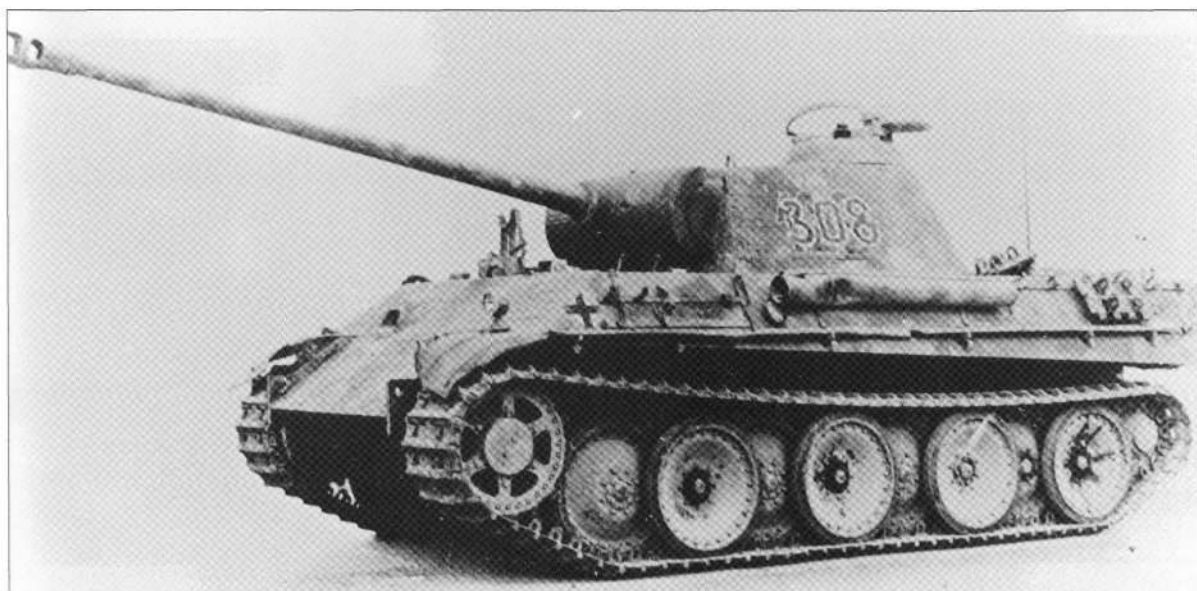
**This mid-production Model G Panther reveals two features that distinguished it from its predecessors – the straight but gently sloping bottom edge of the hull sides, and the rotating driver's periscope mounted on the front left hull roof in place of the driver's visor in the left glacis plate. (The Tank Museum, 553/A6)**

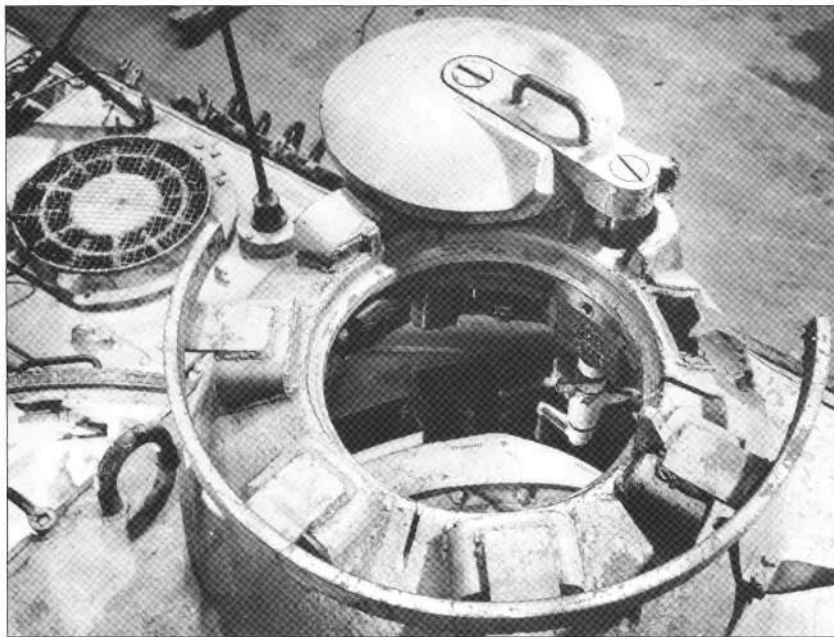
**Model A and G Panthers featured identical commander's cupolas, but the fan louver pattern on this tank and its lack of a conical fitting on the turret roof in front of the cupola just below the prominent spike of the sighting vane identifies it as a late Model G tank. (The Tank Museum, 2903/B2)**

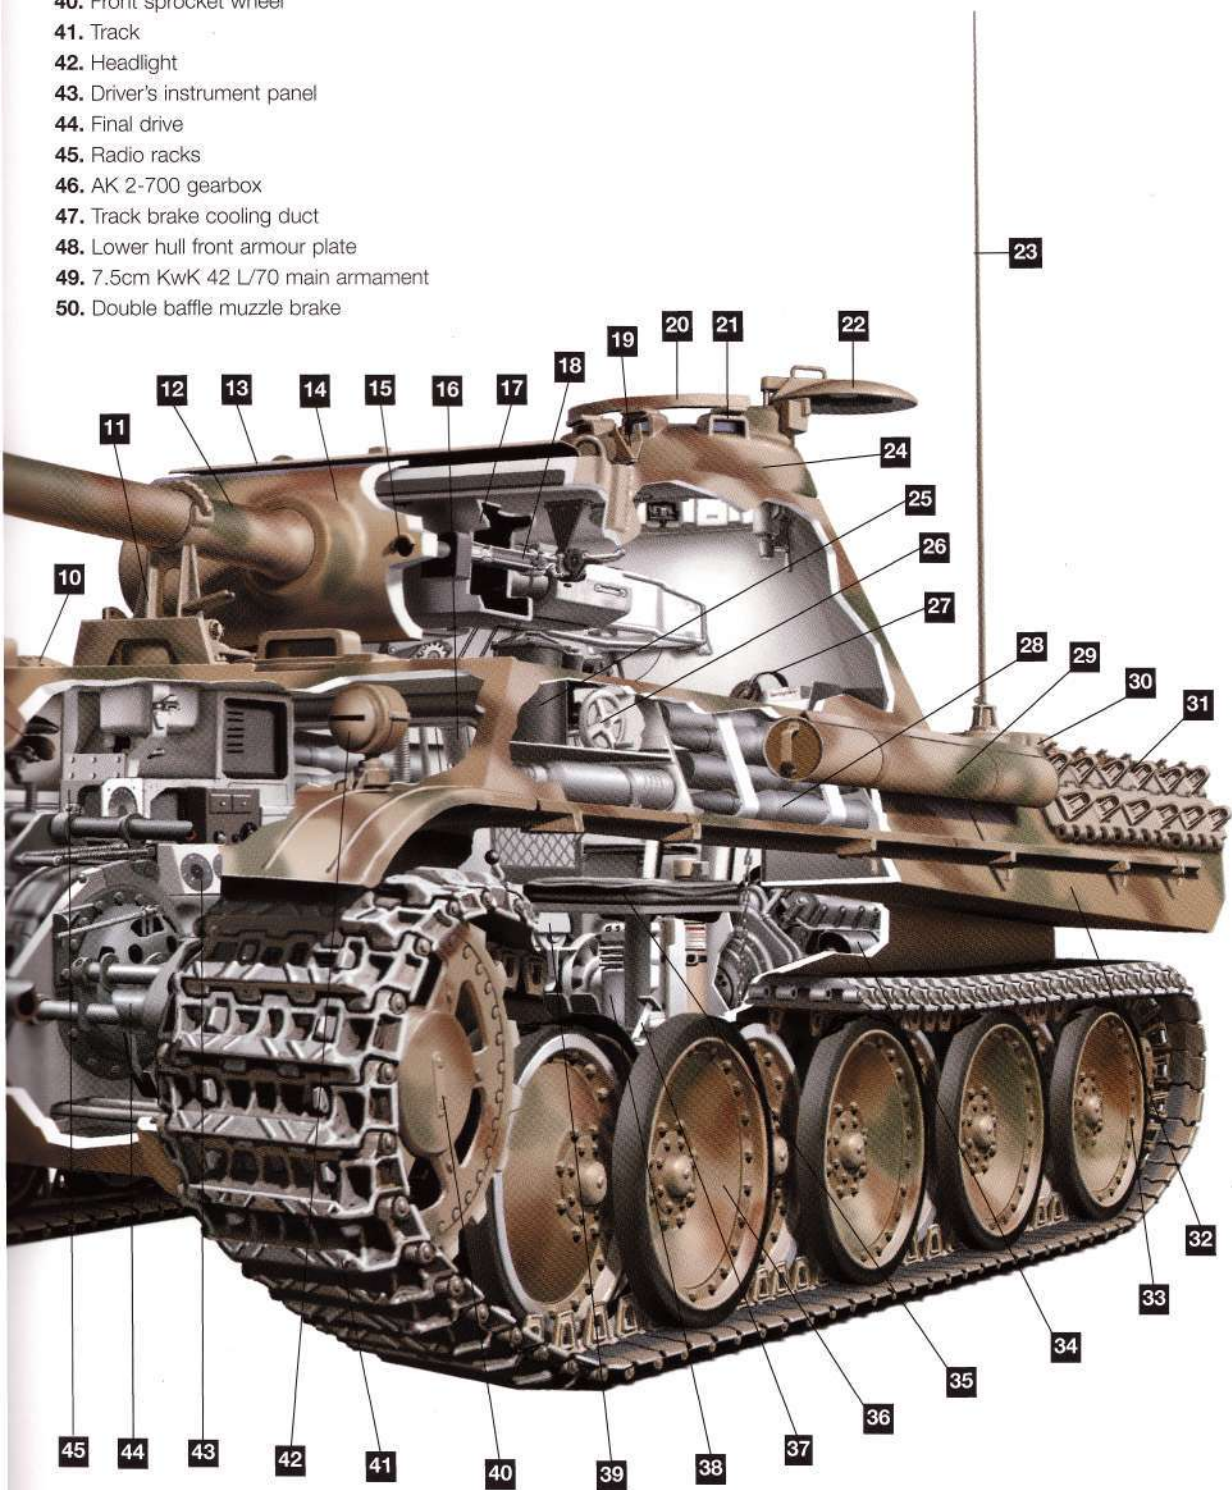
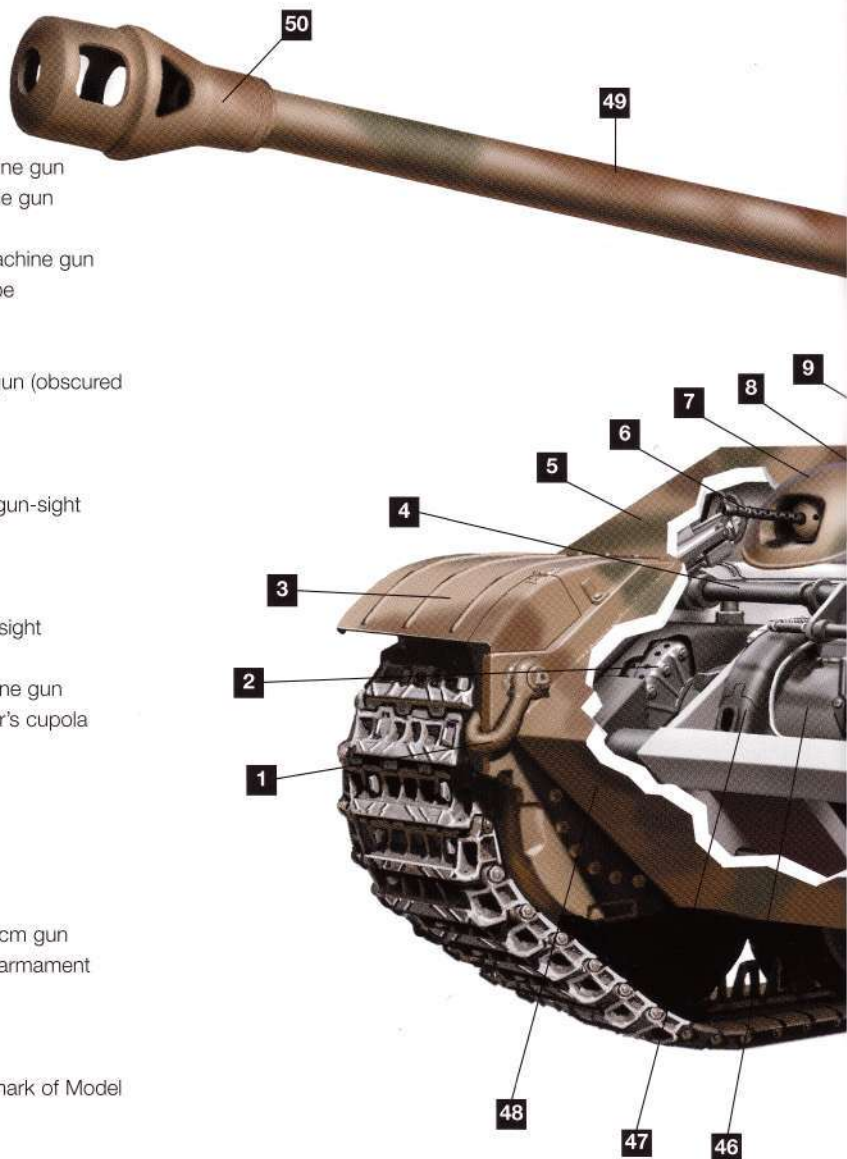
# D: THREE-QUARTER VIEW CUTAWAY OF AN EARLY MODEL G PANTHER IN THREE-TONE CAMOUFLAGE, EARLY SUMMER 1944

- 38. Compressor
- 39. Hydraulic traversing unit
- 40. Front sprocket wheel
- 41. Track
- 42. Headlight
- 43. Driver's instrument panel
- 44. Final drive
- 45. Radio racks
  - 46. AK 2-700 gearbox
  - 47. Track brake cooling duct
  - 48. Lower hull front armour plate
  - 49. 7.5cm KwK 42 L/70 main armament
  - 50. Double baffle muzzle brake

large parts of its interior components on view. The tank's exterior features the standard three-tone camouflage scheme that was increasingly superseded from August 1944 by 'ambush' designs. The former pattern consisted of a base colour of Dark Yellow (RAL 7028), over which random patches of Red-Brown (RAL 8017) and Dark Olive Green (RAL 6003) have been added. The precise features of this basic pattern varied significantly from tank to tank depending on unit practice and the tactical conditions present at that moment. The tank's interior was painted, as standard, in Light Cream (RAL 1001) with interior components in various shades of metallic grey or charcoal, with lettering in Red. The gently sloping straight bottom edge of the rear hull sides identifies this tank as a Model G Panther with its 'straightened' chassis, in contrast to the downward wedge of the rear hull sides seen on previous Model D and A tanks. That this is an early, not a late-production, Model G tank can be discerned by the lack of both a shot-deflecting chin under the mantlet and steel-rimmed road wheels.

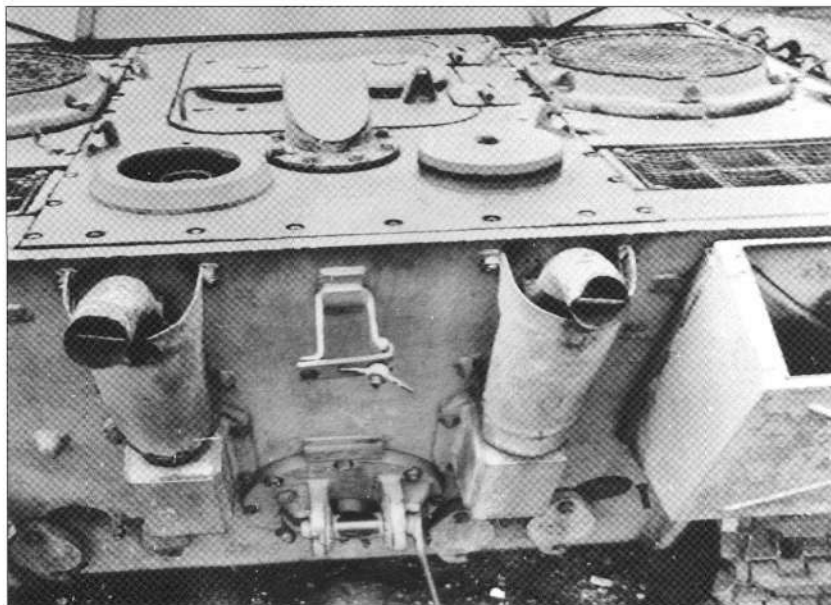
**This late Model G Panther sports a redesigned rear hull decking layout and large sheet-metal guards fitted around each exhaust pipe. German factories incorporated the latter modification after early June 1944 to help conceal the tell-tale glow given off by hot exhausts at night. (The Tank Museum, 2390/C6)**

During September 1944, the factories ceased coating completed Model G vehicles with Zimmerit anti-magnetic mine paste, because of rumours that, when hit, the coating caused vehicle fires. Next, from October the manufacturers began to deliver finished Panthers in their original red oxide primer, with just a few patches of Olive Green, Red-Brown and Dark Yellow camouflage added. That same month, the Germans added an elongated rain guard for the gun sight visor on the mantlet, as driving rain was still found to cause problems when entering the sight. That autumn, the assembly factories also outfitted small numbers of Model G Panthers with infra-red night fighting equipment, as previously described in Osprey New Vanguard 22, *Panther Variants 1942-45*. Next, from September 1944 onwards, the factories fitted some Panthers with a 'chin' along the bottom of the gun mantlet that prevented incoming rounds being deflected down into the hull roof. During this period, a few Panthers also appeared that featured the more resilient steel-tyred road wheels used in the King Tiger and earmarked for the Panther II. Moreover, during the last weeks of the war, MAN produced a few Model G tanks that had a solitary pair of steel-tyred road wheels at the rear station alongside seven pairs of ordinary rubber-tyred wheels, either to compensate for particularly heavy wear on this station, or simply because there was a shortage of available rubber-tyred wheels. Finally, the last modification incorporated into the Model G before production ended in April 1945 was a new exhaust muffler that reduced the problem of the glow sometimes generated by tank exhausts at night.

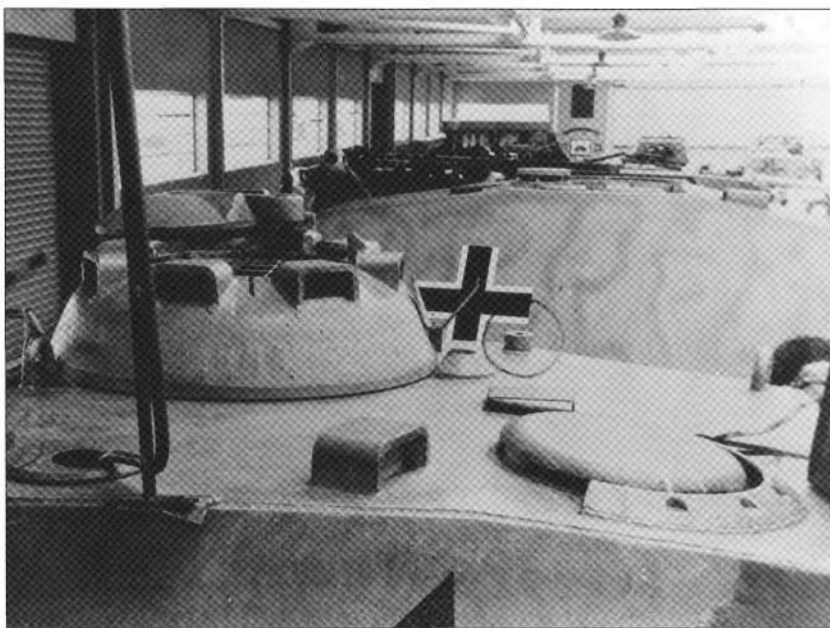
**This late Model G Panther, constructed by British forces in mid-1945, is today displayed at the Tank Museum, Bovington. Two of the three small jib boom sockets fitted on Panthers from June 1944 can be seen on the rear right and central left of the turret, as can a conical fitting in front of the cupola underneath the sighting vane. The purpose of the latter device remains unclear, but it may have been connected with the unrealised German intention to mount infra-red equipment on the cupola. (The Tank Museum, 2391/C2)**

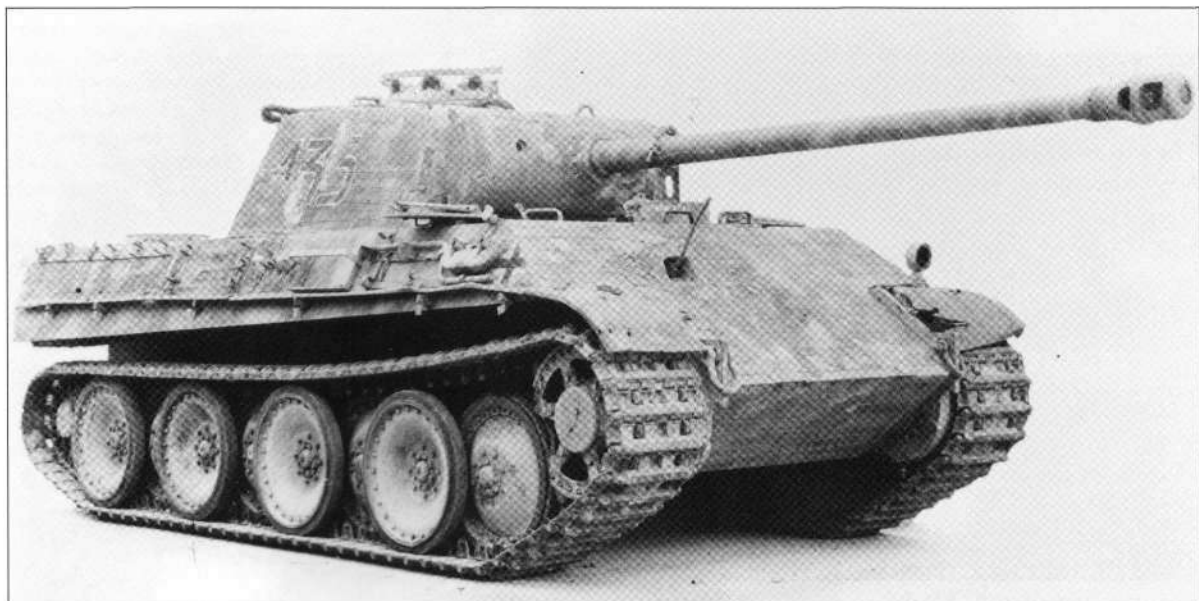
**Early Model G Panther number 435 sports the ripple effect left when the tank was coated with Zimmerit anti-magnetic mine paste. After September 1944, however, German factories stopped applying the paste after post-combat reports alleged that the Zimmerit caught fire when enemy rounds hit the tank. (The Tank Museum, 6087/C6)**

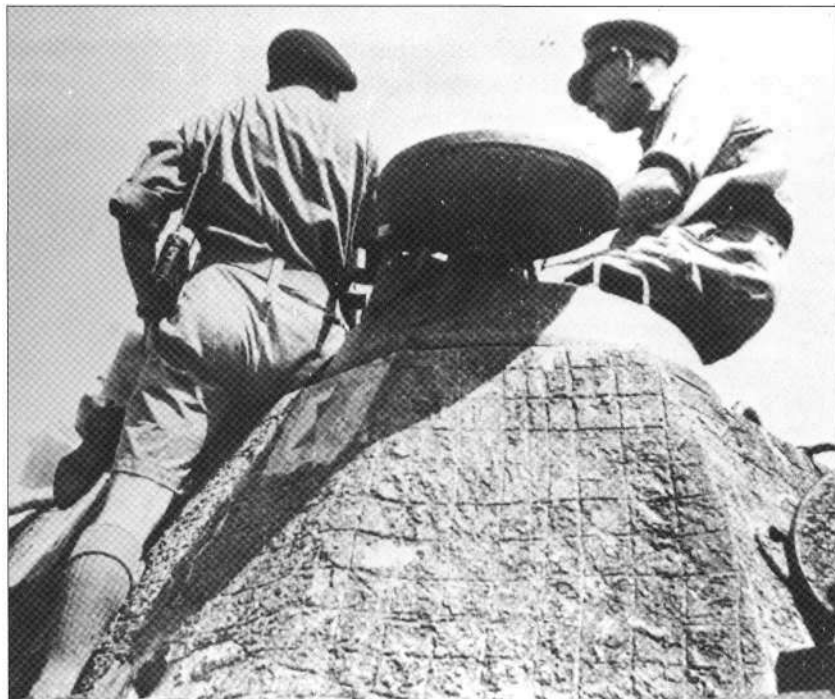
**This close-up view of the rear left side of a Panther turret underneath the commander's cupola reveals the uneven texture left by Zimmerit paste. The vehicle has been captured by British forces, who are here inspecting their prize. (The Tank Museum, 2903/C1)**

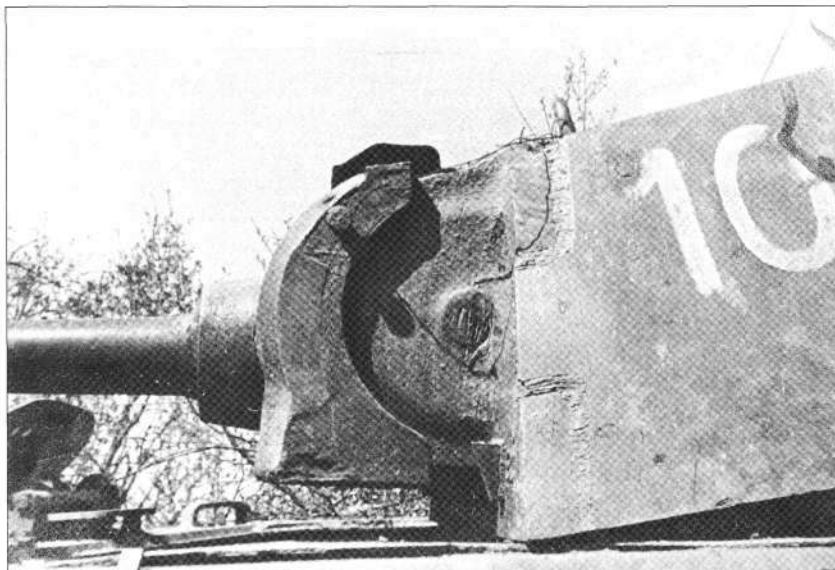
This late Model G Panther sports a debris guard fitted to the top of the mantlet and a distinctive shot-deflecting mantlet chin, as well as a square-cut joint where the turret side fitted to the turret front plate, which contrasted with the dove-tailed joint featured on the Model D. (The Tank Museum, 22/F2)
