# Panther Medium Tank 1942–45

Stephen A Hart • Illustrated by Jim Laurier

New Vanguard • 67

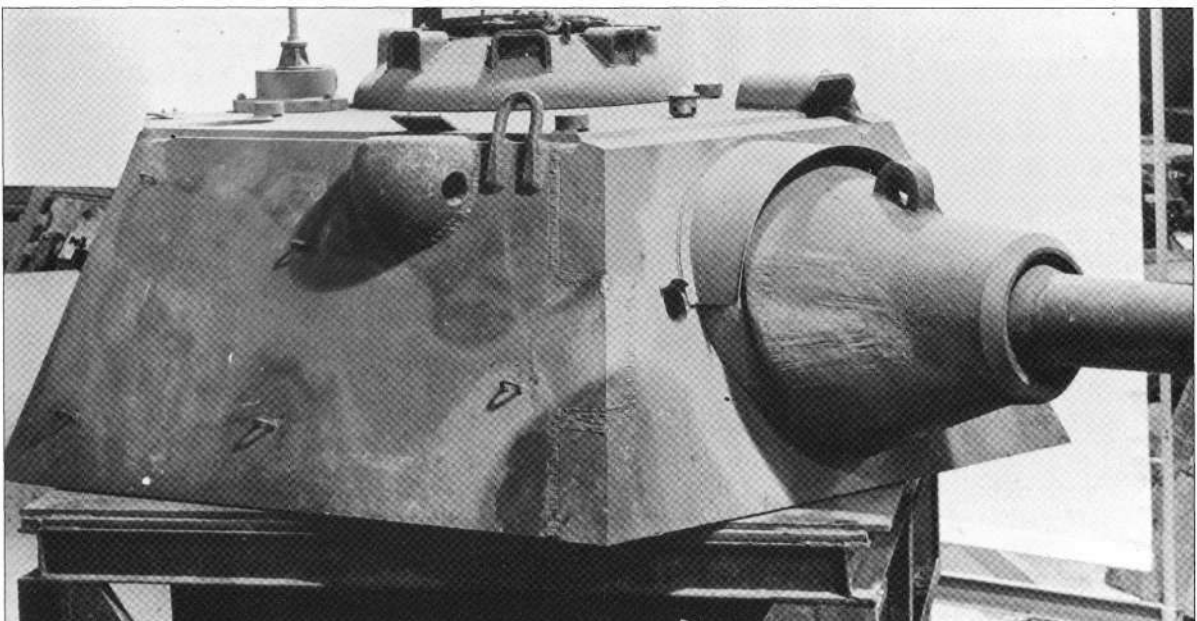
**The war ended before the Germans could deploy at the front any completed Model F Panthers, the variant that mounted the Narrow Turret (Schmalturm) on a slightly modified Model G chassis. (The Tank Museum, 2907/F3)**

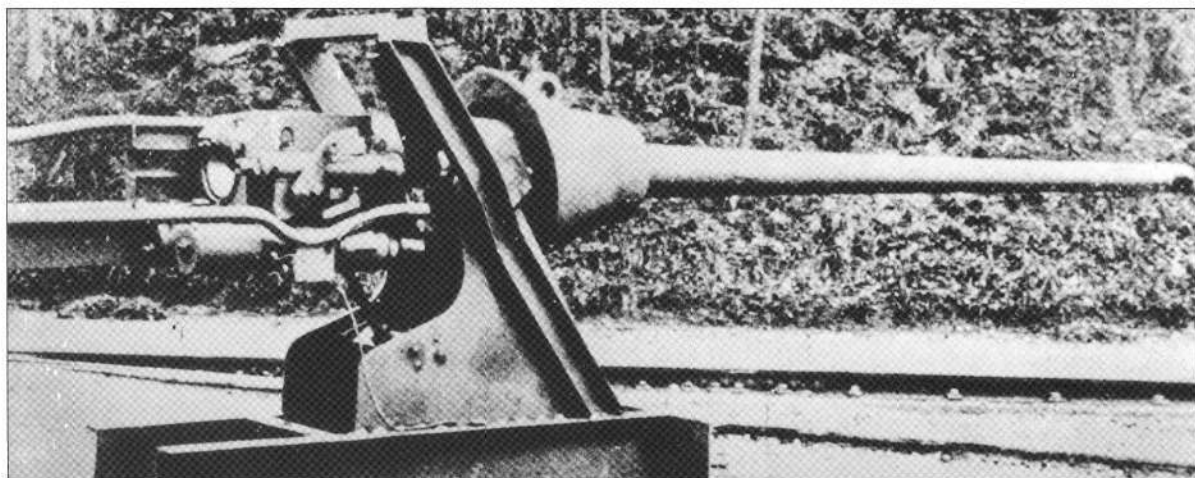
**The Narrow Turret incorporated into the Panther Model F mounted a narrow conical mantlet that housed the 7.5cm KwK 42/1 L/70 gun, a modified version of the standard KwK 42 Panther gun. (The Tank Museum, 2391/C1)**

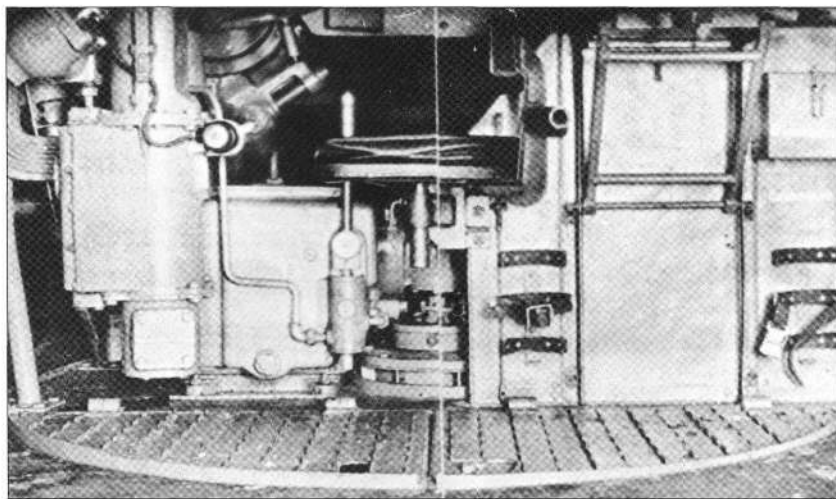
This interior view of a Panther tank turret, as seen from the left, shows the gunner's seat in the centre of the picture, while the TFZ periscope remains just out of shot above the top left of the photograph. (The Tank Museum, 11/B5)

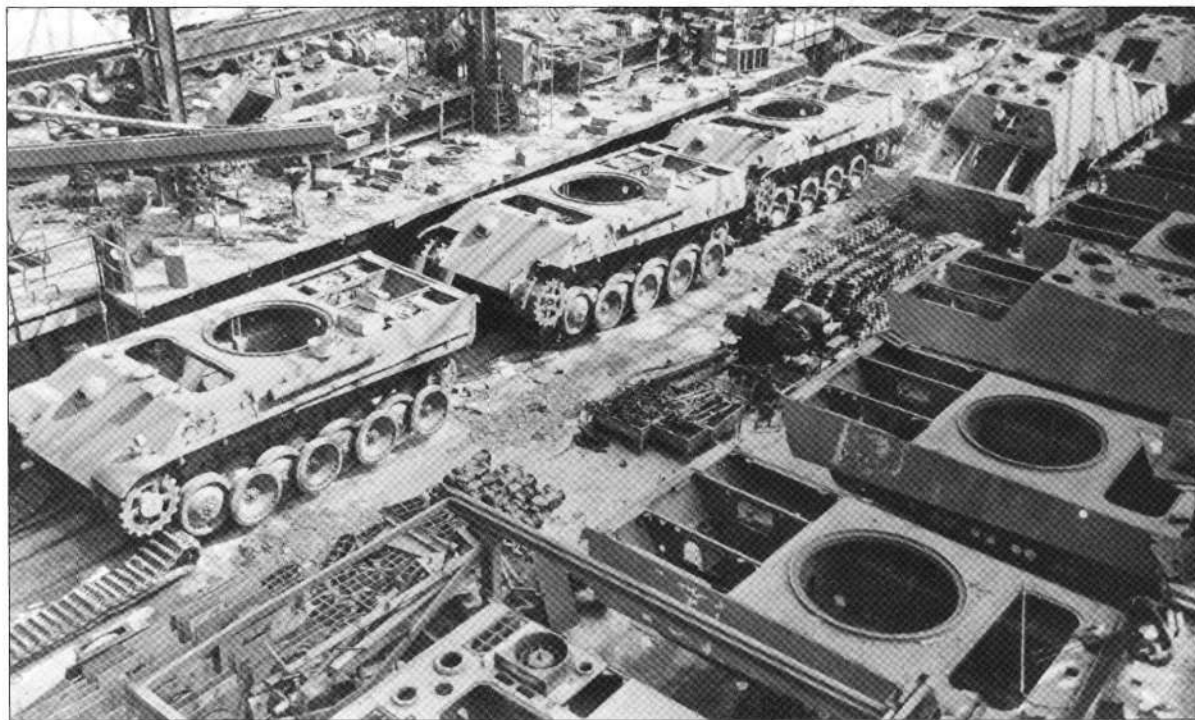
**Unfinished Panther tank hulls and Jagdpanther heavy tank destroyers can be seen on this production line at one of the five armament factories located in the Reich that manufactured the Panther tank. (The Tank Museum, 4049/C3)**

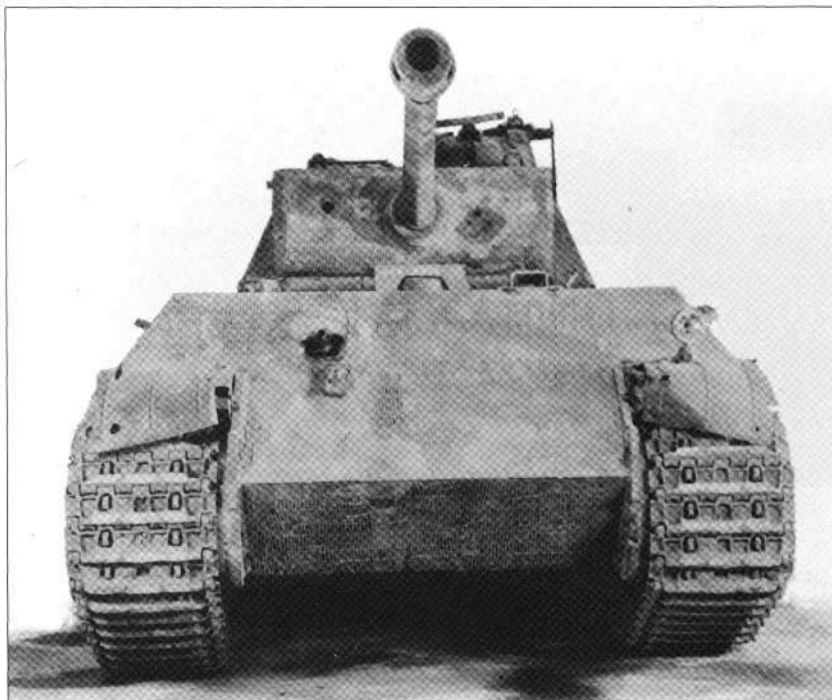
**Model G Panthers such as this vehicle spearheaded the advance made by Battle Group Peiper toward the Meuse bridges during the mid-December 1944 German Ardennes offensive. Note the absence of the driver's visor on the left hull glacis plate. (The Tank Museum, 6087/D1)**

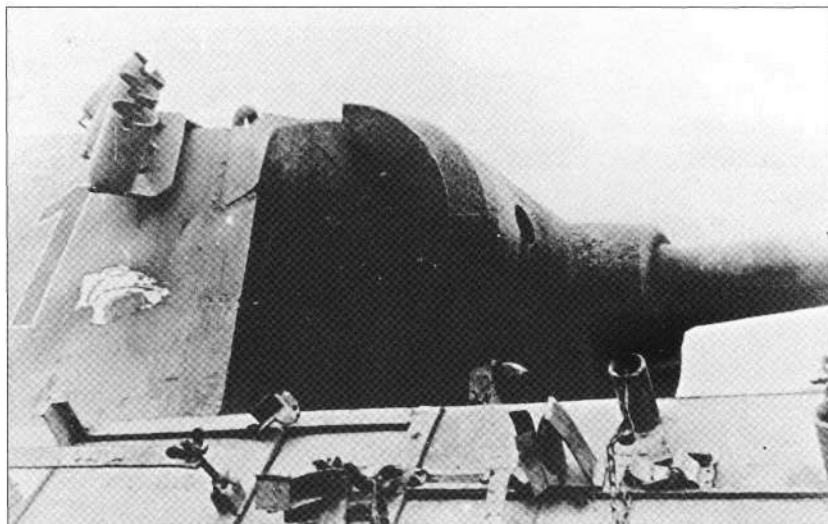
**This Soviet photograph of a captured early Model D Panther illustrates well the 51st Panzer Battalion's tiger symbol, the circular shape of the gun mantlet, and the form of the three smoke-grenade launchers mounted on each turret side. (The Tank Museum, 22/E1)**

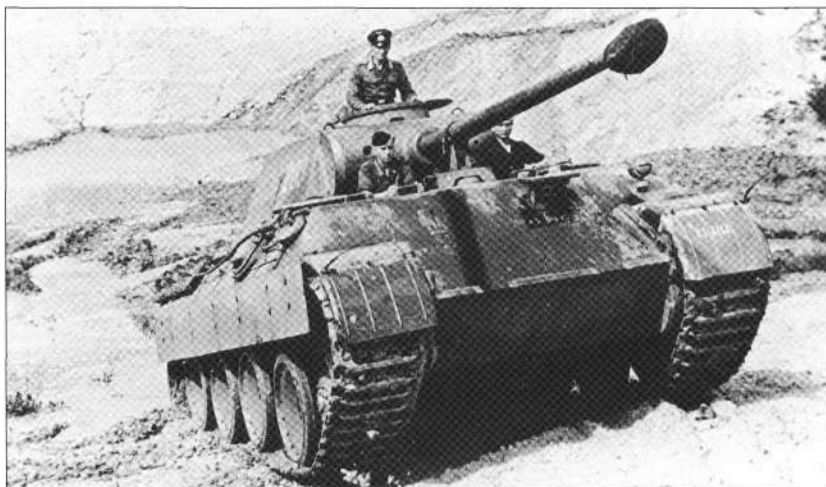
**RIGHT** This Daimler-Benz late Model D Panther, chassis number 211213, seen at the 15th Panzer Division training area at Sagan during autumn 1943, featured Schürzen skirting plates mounted on the side of the vehicle to protect the track and hull sides from enemy fire. (The Tank Museum, 341/H6)

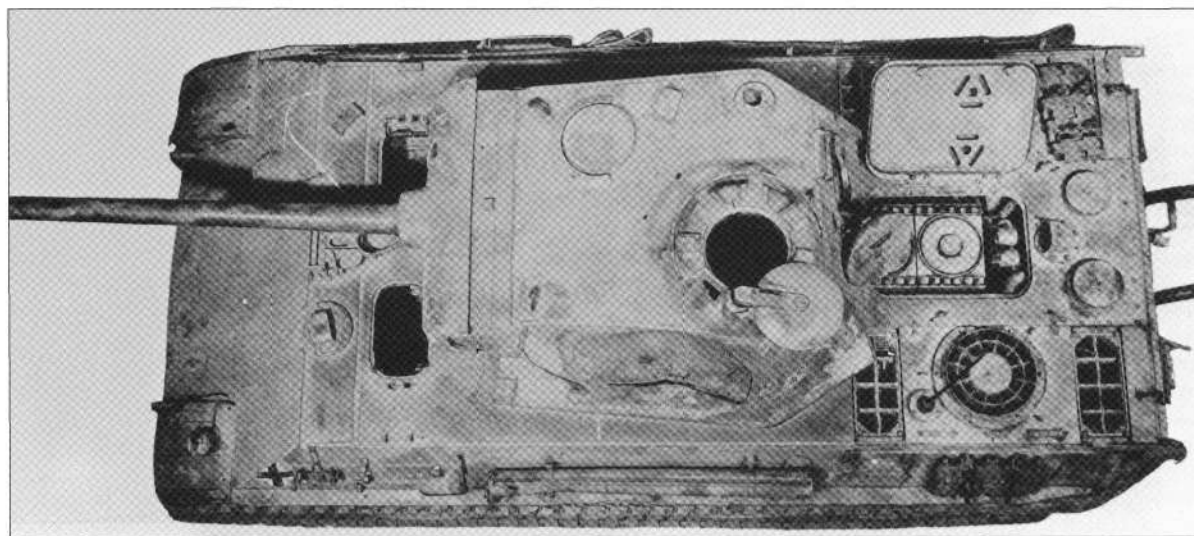
**This early Model G Panther sports redesigned driver's and radio operator's hatches in the front hull roof, and a modified rear hull roof with altered fan louvers. The shape of the driver's periscope on the front left hull roof distinguishes this vehicle from late Model G tanks that featured a larger periscope. (The Tank Museum, 2902/D2)**

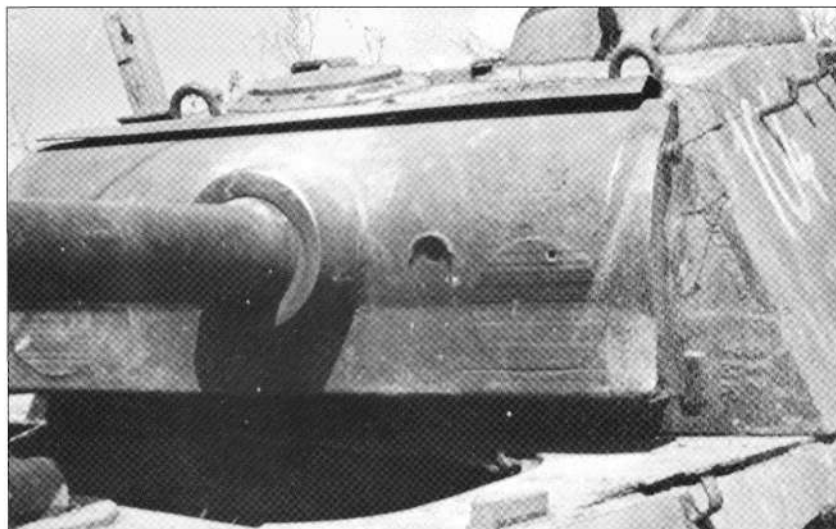
**LEFT** This Panther is identified as a late Model G tank, completed after August 1944, by the distinctive chin added to the mantlet to prevent incoming rounds being deflected down onto the thin hull roof armour. Note the hooks on the turret sides onto which the crew could mount spare track sections. (The Tank Museum, 2903/A6)

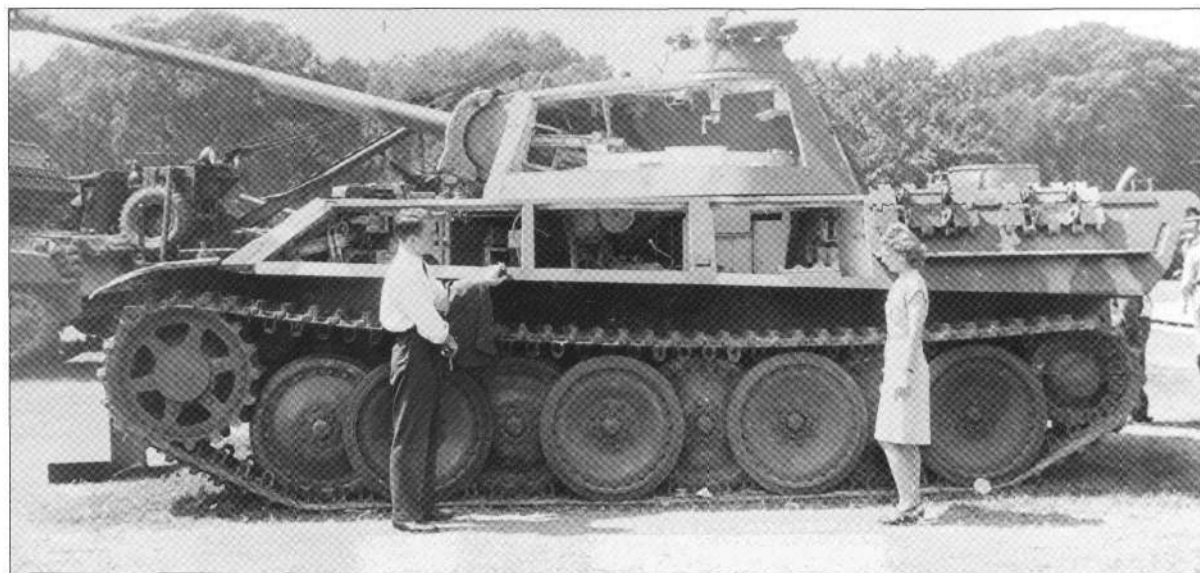
**BELOW** In the cutaway turret of this late Model G Panther with mantlet chin can be seen a TFZ 12a periscope, a superb targeting device that enhanced the lethality of the Panther's superb 7.5cm gun. (The Tank Museum, 2390/F2)
