New Vanguard

British Mark I Tank 1916

David Fletcher • Illustrated by Tony Bryan

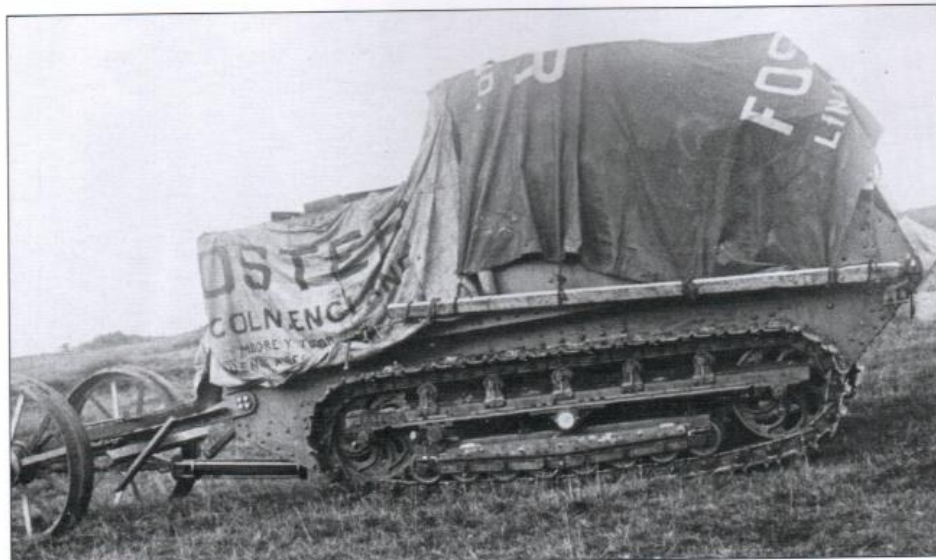
Draped with tarpaulin covers disguise its warlike purpose, the *Lincoln Machine* is shown during trials. This photo was taken after the tracks had been modified, but they still proved unsuitable for the work they would have to do.

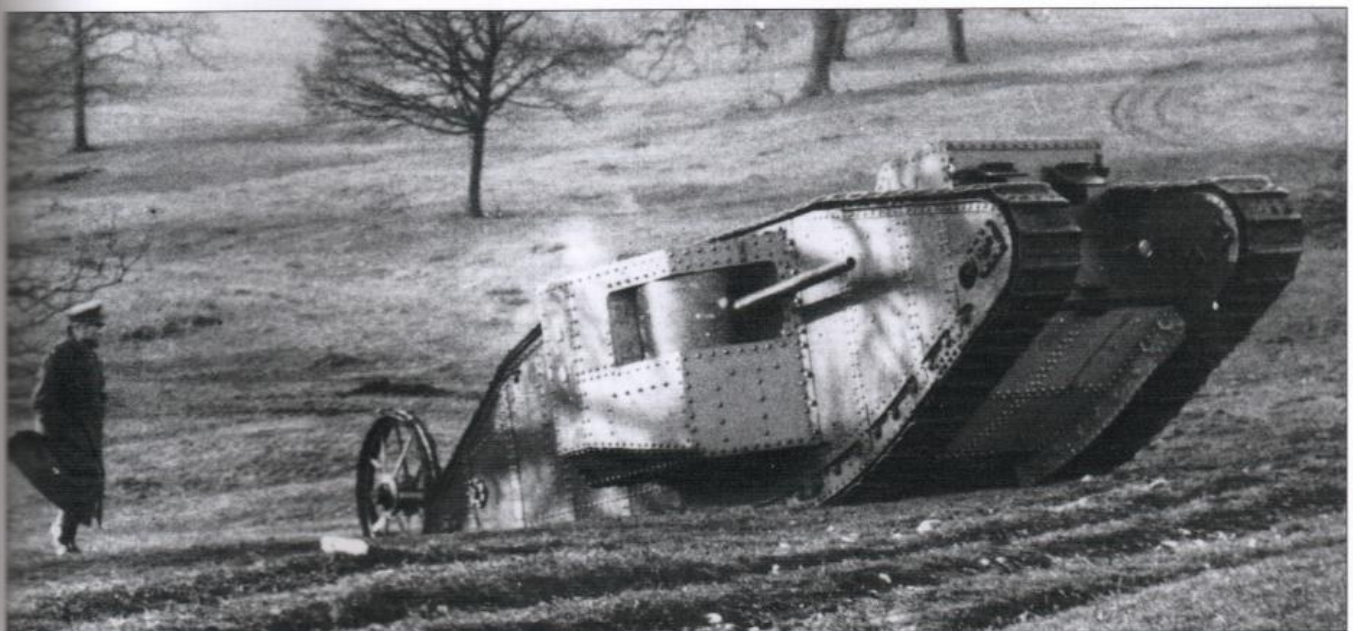
Mother in Hatfield Park. The front of the cab is virtually identical to that of *Little Willie* but the tracks are now the dominant feature and they limit the driver's view. The weapon sponsons, on the other hand, look like a clumsy afterthought.

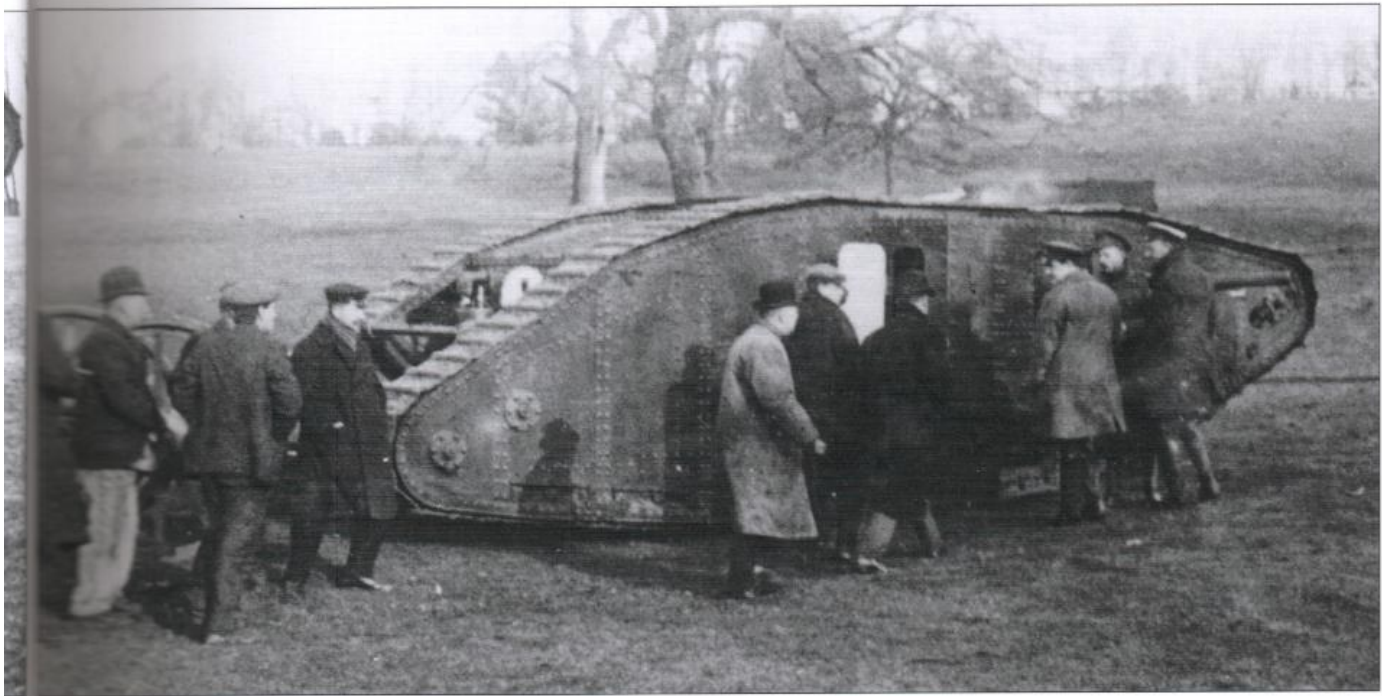
In this near perfect side view the close pattern of rivets shows up well and the sponson appears to be much more a part of the design. The bearing caps just in rear of the sponson indicate the location of the secondary gear shafts.

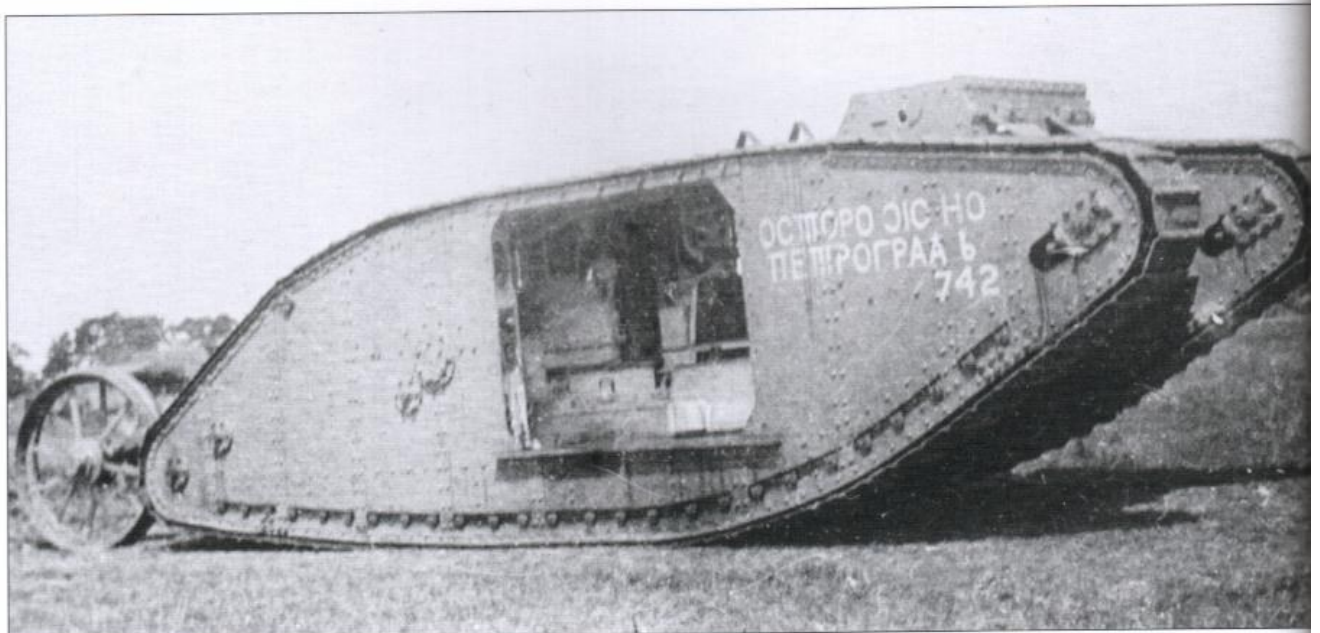
During initial training at Thetford tanks invariably ran without their sponsons, which some felt was foolish. Notice the vision slit and open pistol port on the side of the cab. It also clear that 742 has been losing a lot of engine oil.

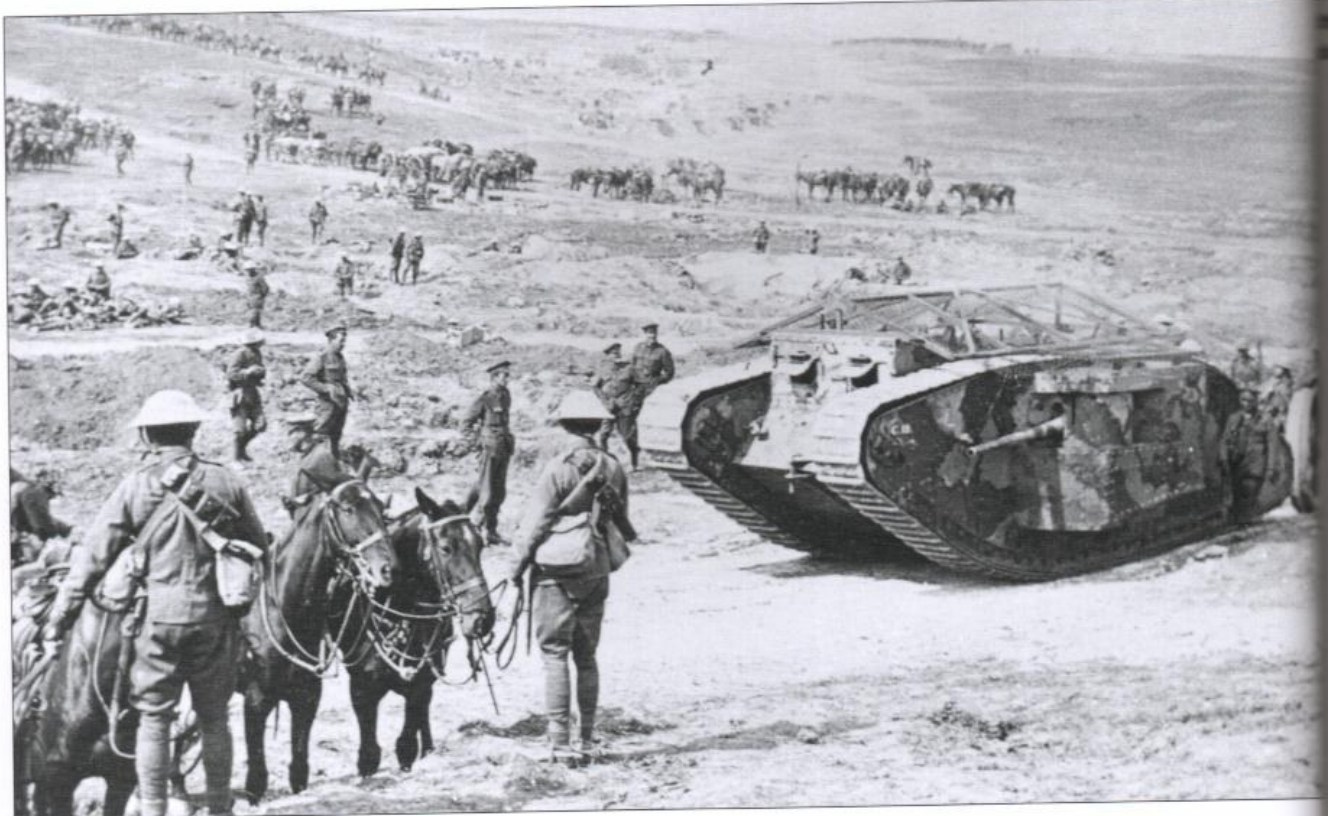
Everyone stops to watch as *Clan Leslie* makes its way along Chimpanzee Valley en route to the front. The camouflage is particularly striking and includes the gun barrels. The driver appears to be using the tail wheels to bring the tank's nose round a few degrees.

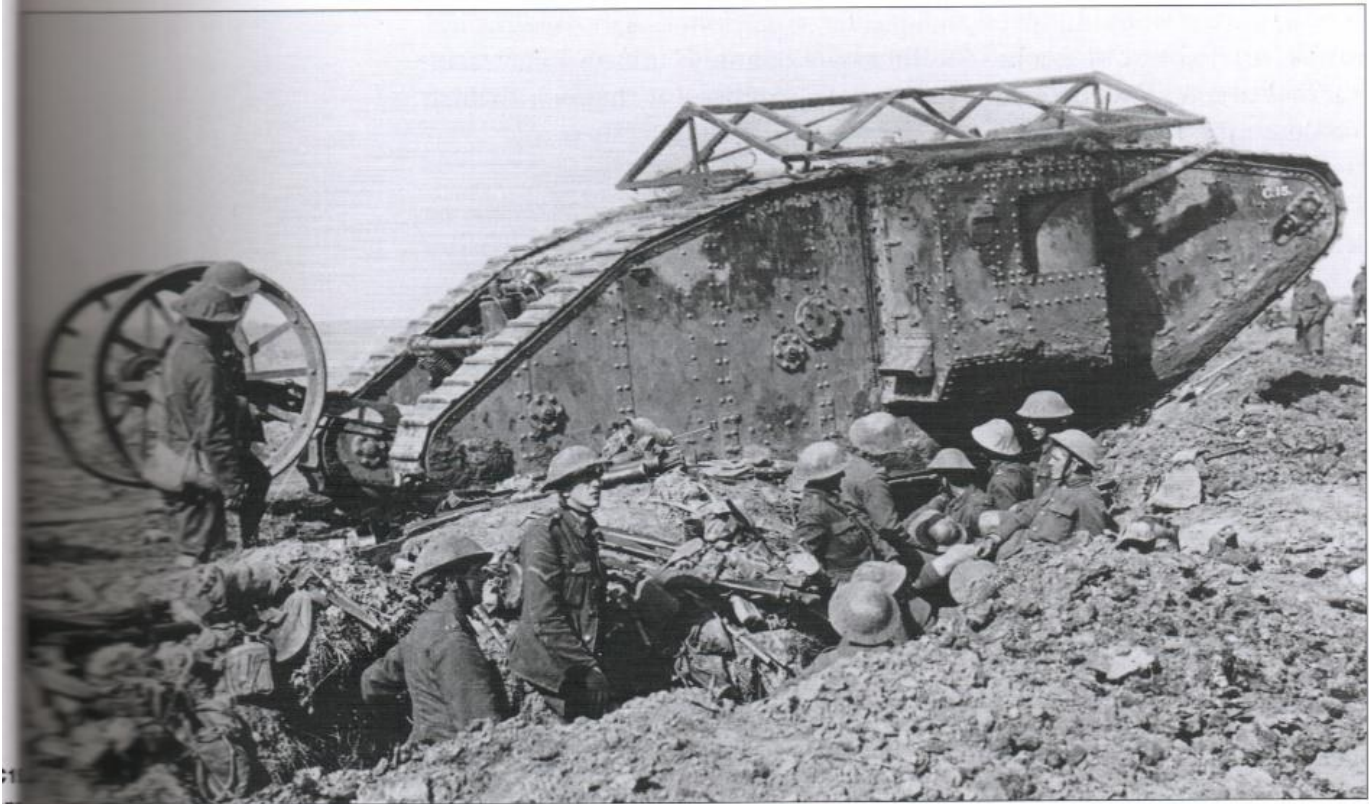
Another classic photograph; C15 moving up for the attack on Thiepval on 26 September 1916. The tank is thickly plastered at the front and seems to have utilised much of the camouflage. The tank is running with its tail clear of the ground, the gun on full elevation and steam shut.

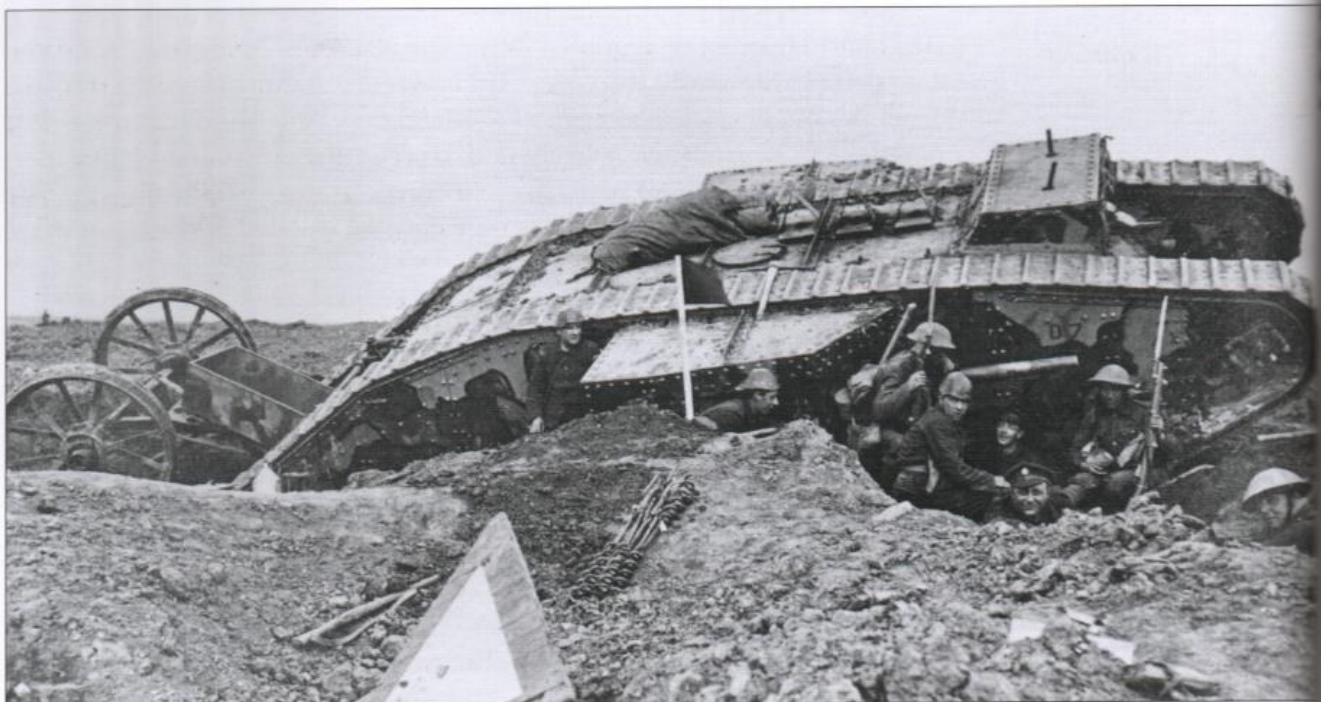
D7 ditched. Notice the two periscopes sticking out of the cab roof, the top hatch, the front Hotchkiss machine gun still in place and the camouflage box on the tail. D Company had to manage without anti-grenade roofs on their tanks but see two crew members wearing their leather helmets.

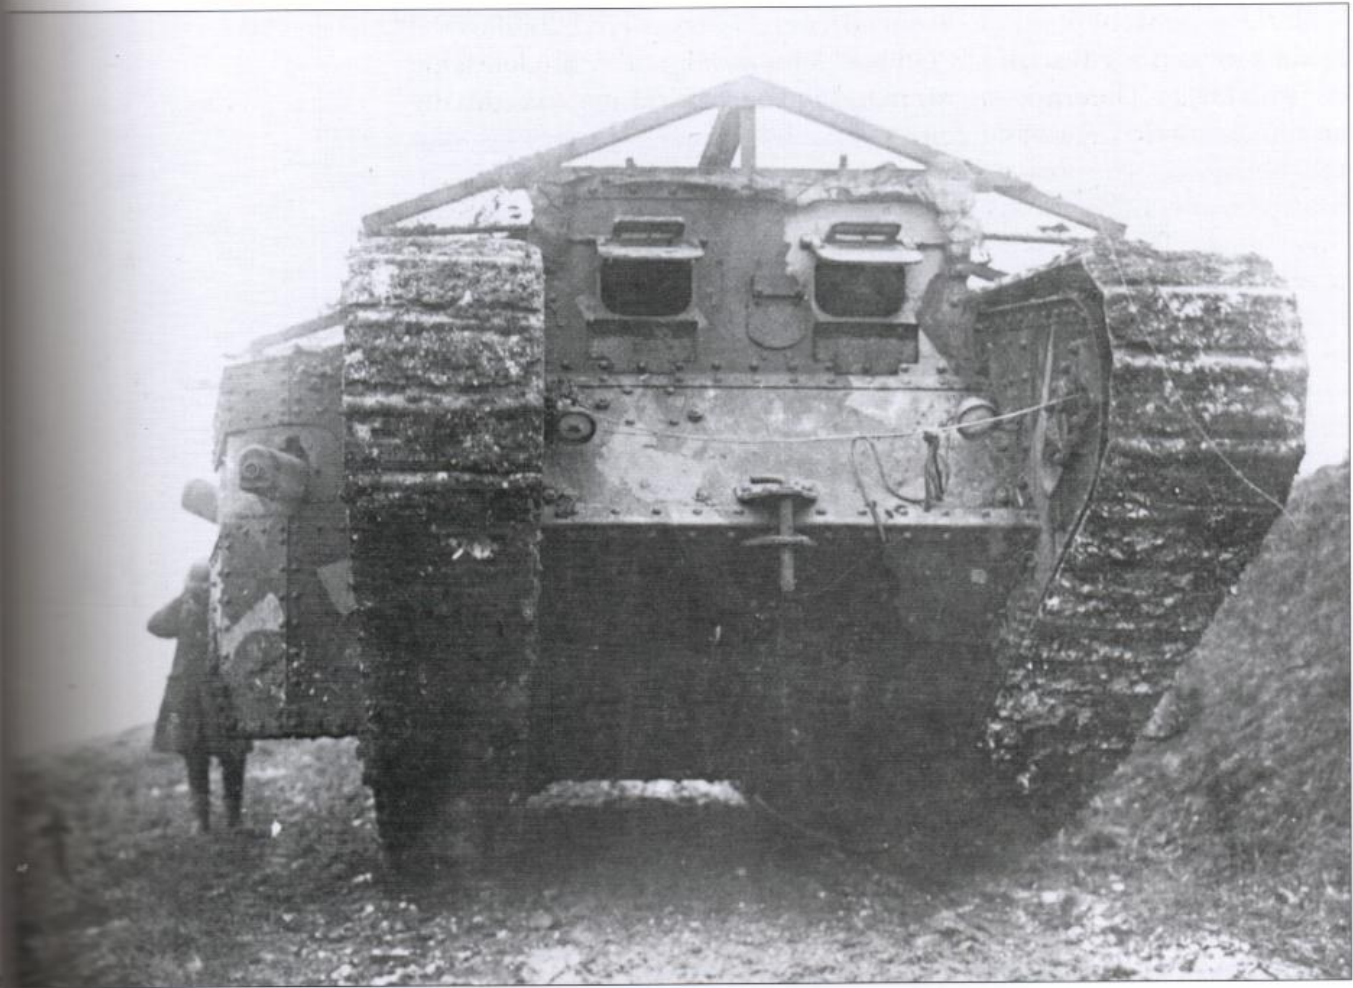
Close-up frontal view of a female Mark I, probably of A Company during the November 1916 actions. This company also employed the grenade-proof roof, but this one seems to have an extension over the top of the turret, which would make sense.

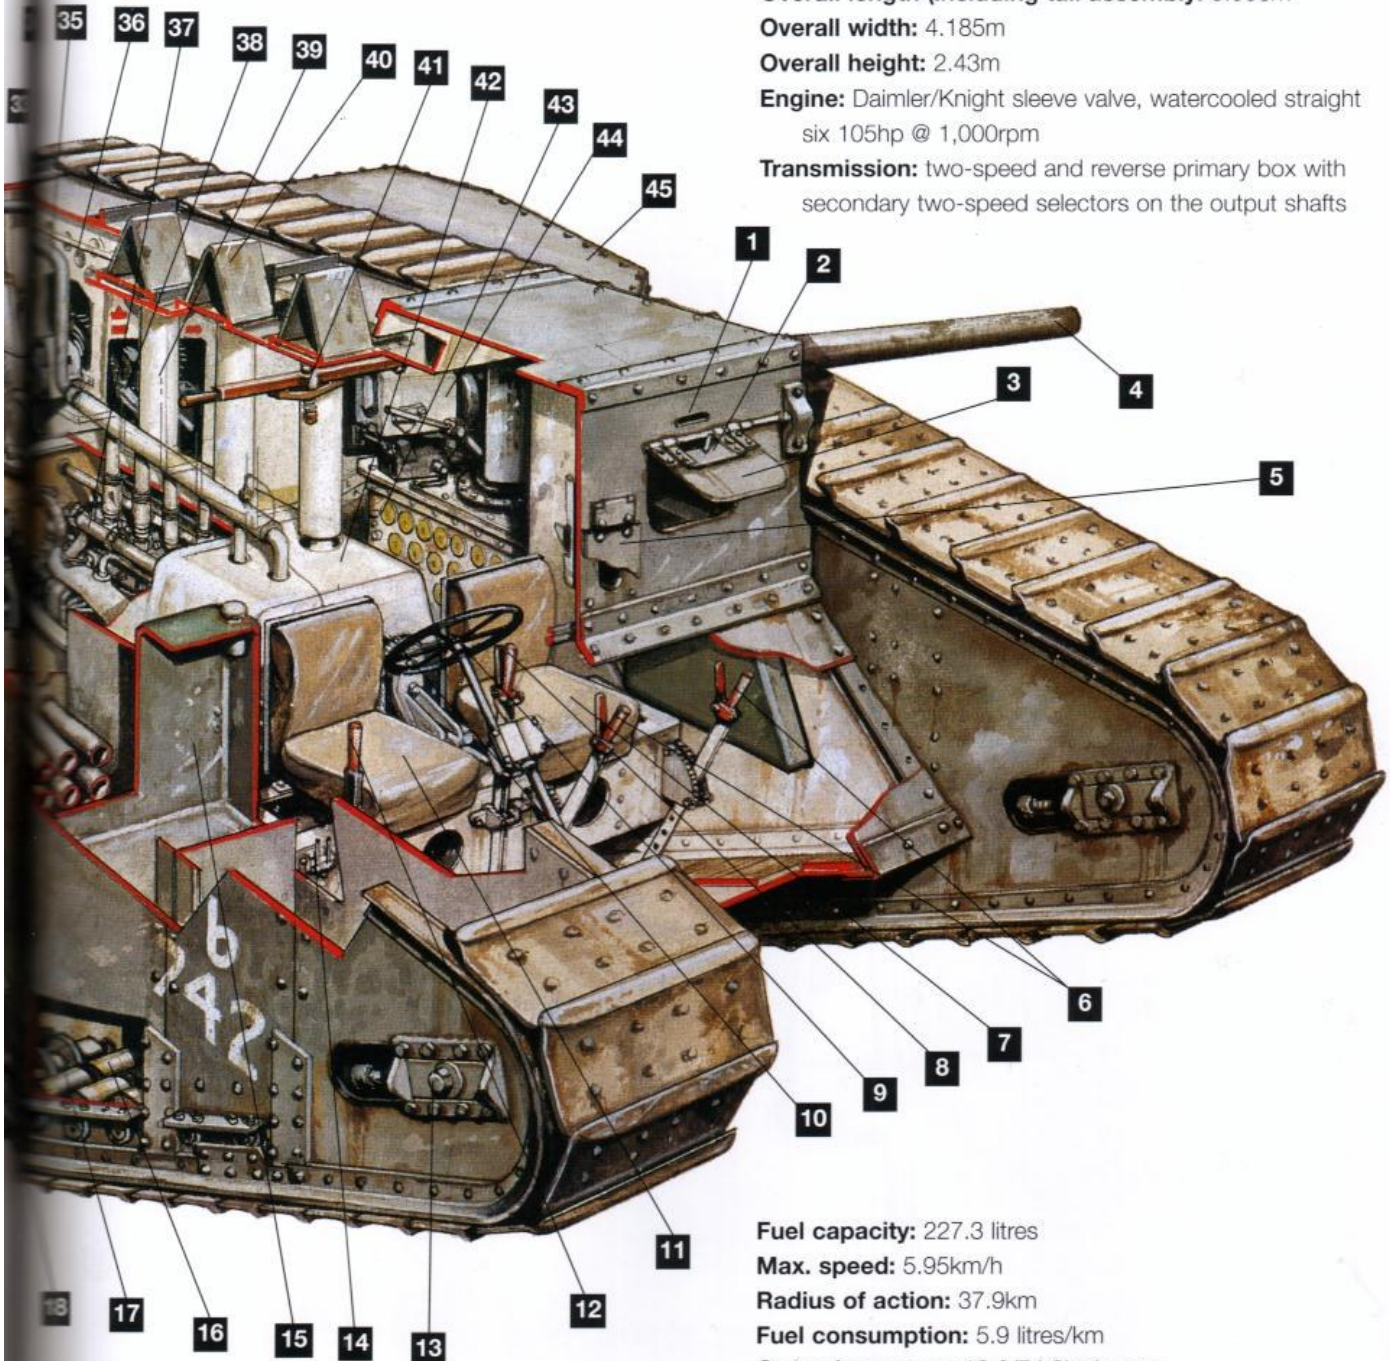
D: MARK I MALE TANK, NO. 742, IN ORIGINAL CONDITION

(tank D7 of No. 2 Section, D Company, Heavy Section Machine Gun Corps commanded by Lieutenant A. J. Enoch at Flers, 15 September 1916)

Engine: Daimler/Knight sleeve valve, watercooled straight six 105hp @ 1,000rpm

Transmission: two-speed and reverse primary box with secondary two-speed selectors on the output shafts

Fuel capacity: 227.3 litres

Max. speed: 5.95km/h

Ammunition stowage: 332 6-pdr, 6,272mg

D: MARK I (MALE) TANK, NO. 742, IN ORIGINAL CONDITION

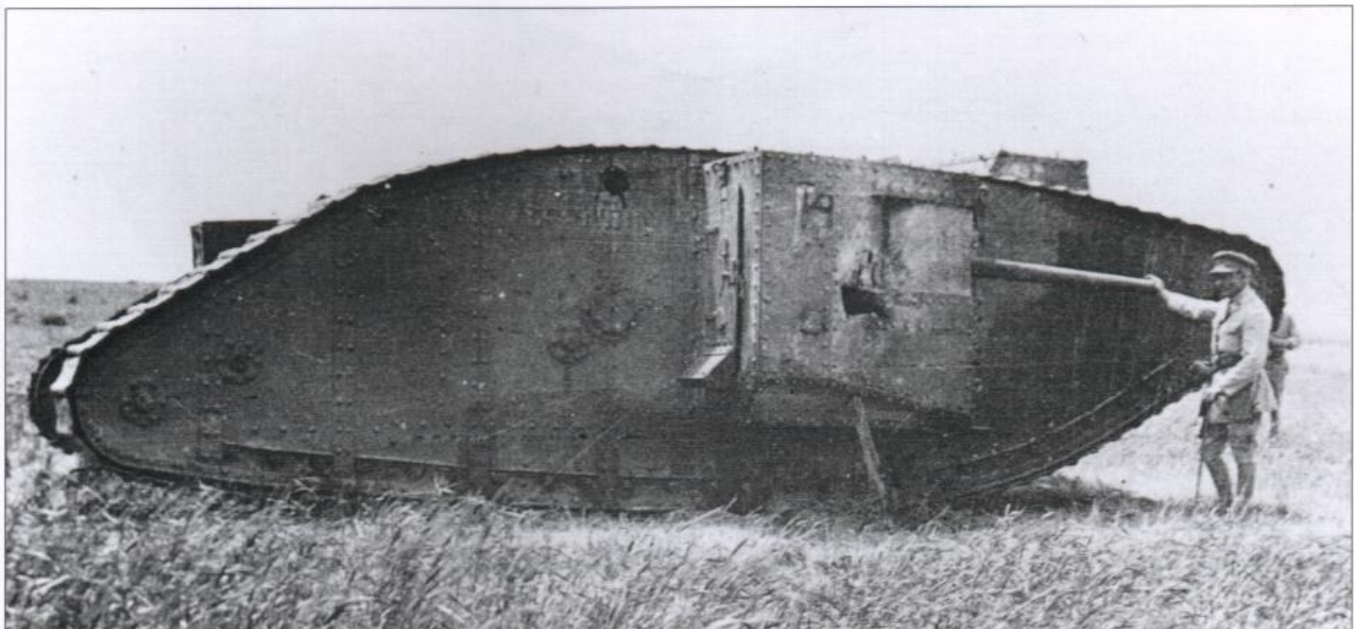
His Majesty's Land Ship *Pincher* serving with Major Nutt's detachment from E Battalion at Gaza. Keeping these old tanks running in a hostile climate, with few spares and inadequate workshop facilities, was a magnificent achievement by any standards.

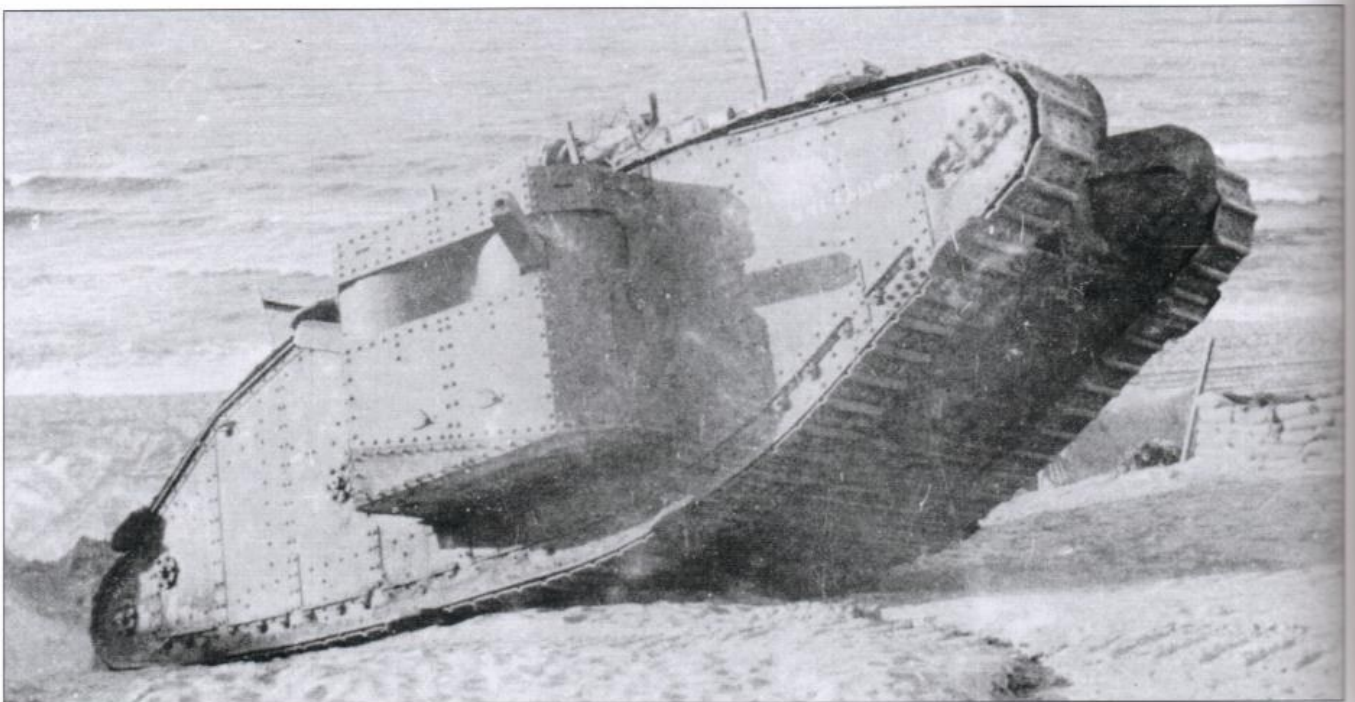
HMLS *Kia-Ora*, one of Nutt's Female tanks. Notice the use of track extenders, the extra panels inside the front horns (presumably to prevent sand being blown back into the cab) and the upright posts on top to keep stores in place.

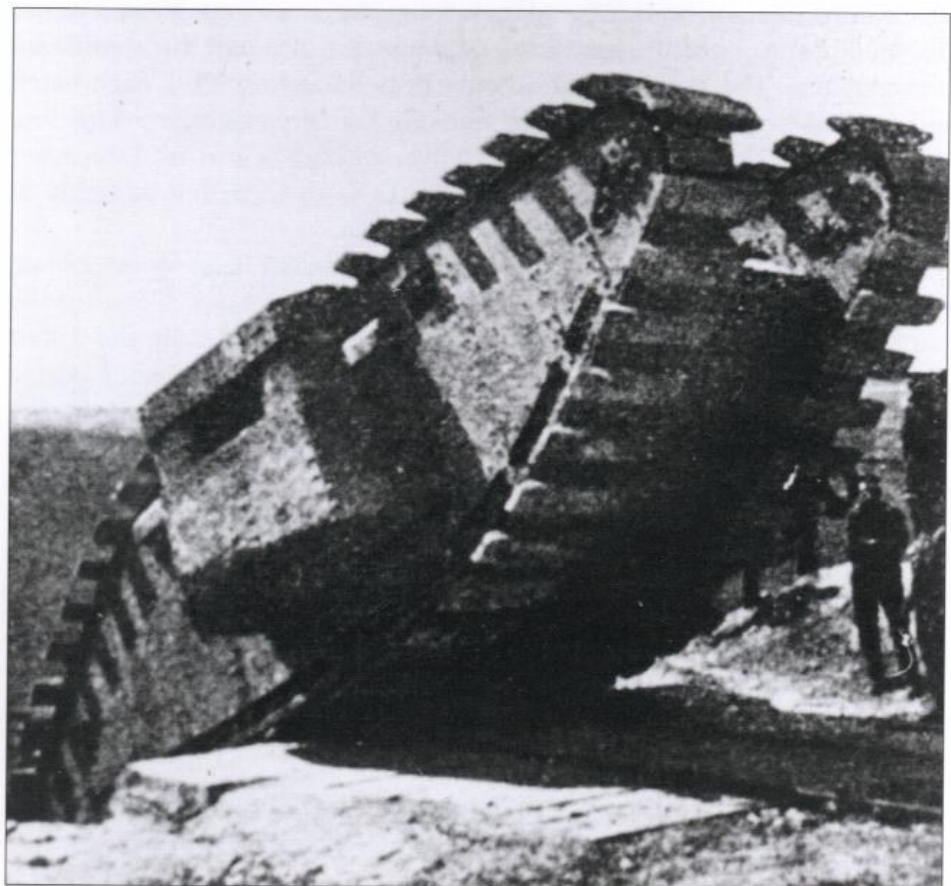
A poor but rare photo of a Female tank, fitted with special climbing spuds, tackling a mock sea wall during training for Operation Hush. This climb must have been a driver's nightmare. Had the operation gone ahead Mark IV tanks would have been employed.

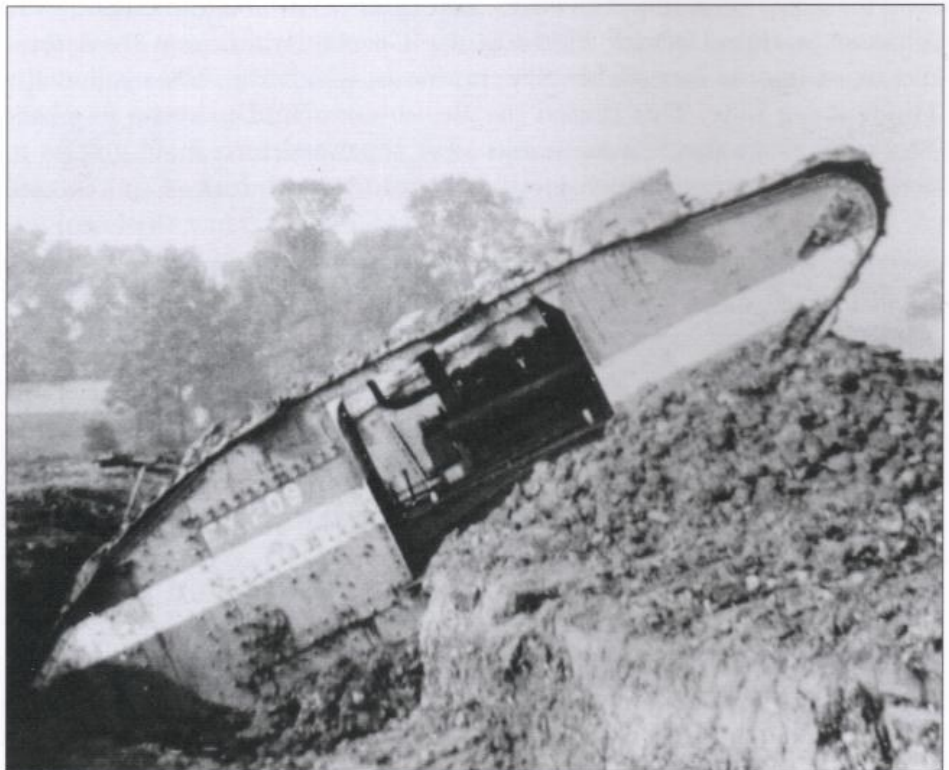
Experimental machine 209, one of the Oldbury Trials tanks, crossing a trench at Dollis Hill. The broad coloured stripe served to identify competing machines. The five Mark II tanks all ran without sponsons and many other detail fittings were not attached.

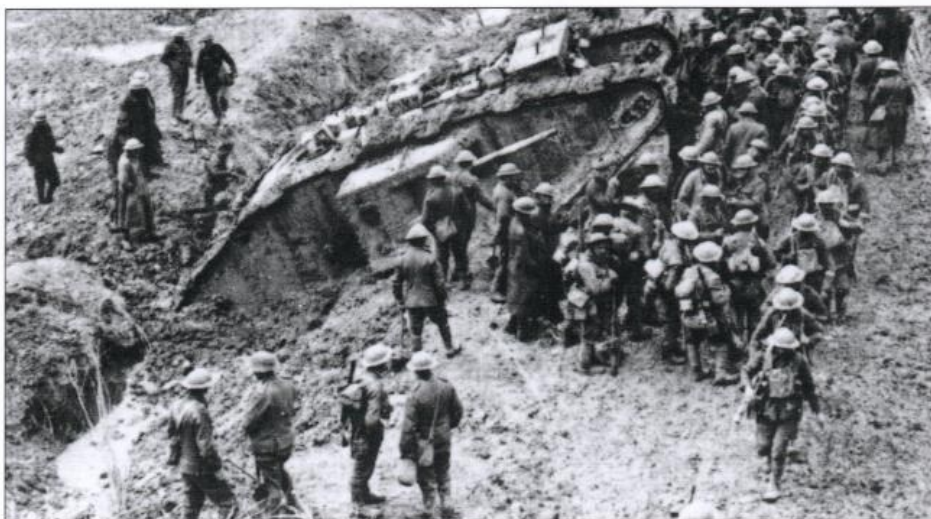
The only known view of a Mark I at Arras, 2nd Lieutenant Tarbet's C6 (No. 752) ditched close to the Blangy Road. Shorn of its tail and fitted with track extension plates it can only be identified by the shape of the track adjustment recess which is more rounded than on the Mark II.

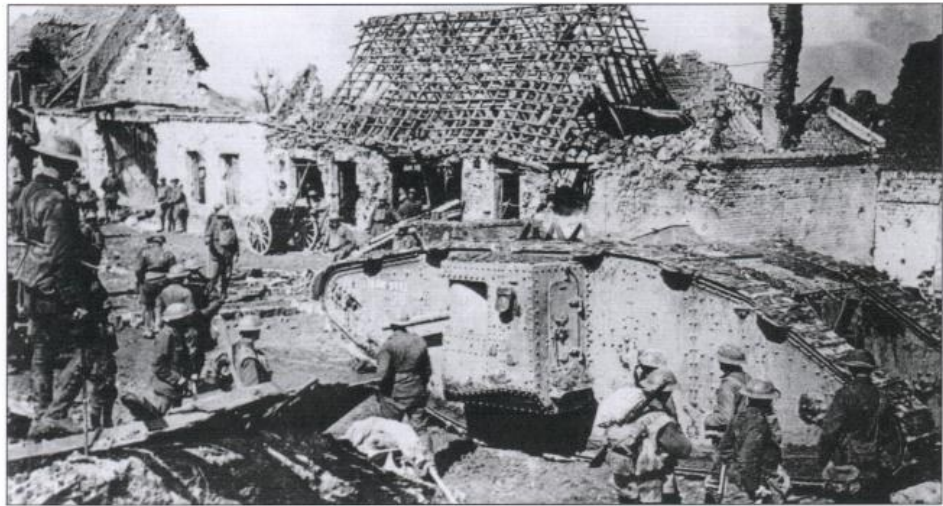
Iron Duke, a Mark II Male, makes its way through Arras displaying well the track extenders, V-shaped exhaust baffles and new style of roof top hatch. Notice how mud smears the lower extremities of the sponson and is piled on top from the action of the tracks.

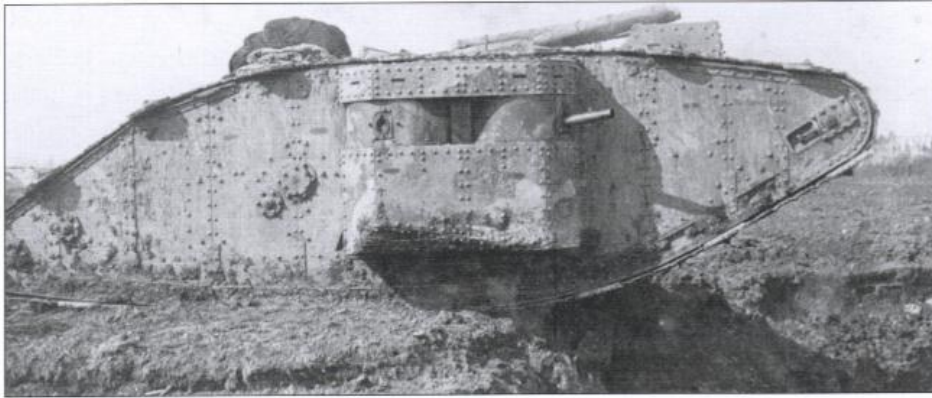
A Mark II Female, *The Perfect Lady*, at Arras. The camouflaged sponson must have come from a Mark I but it now carries a pair of Lewis guns. It seems that the crew have painted artificial vision slits on the hull and sponson sides. German soldiers were ordered to aim specifically at vision ports.

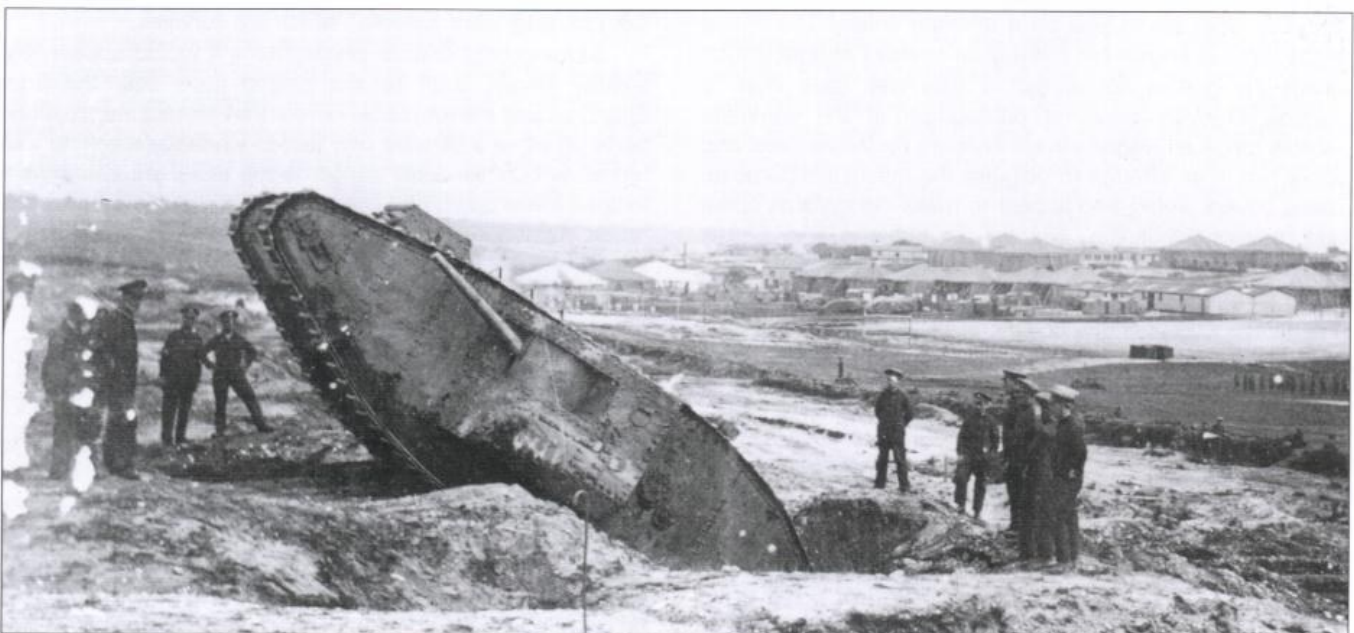
With the new military settlement of Bovington Camp in the background, a Male Mark III, complete with guns, demonstrates the technique for getting out of a difficult hole. Traces of camouflage along the top of the sponson and on the gun barrel suggest this may have been taken from a redundant Mark I tank.

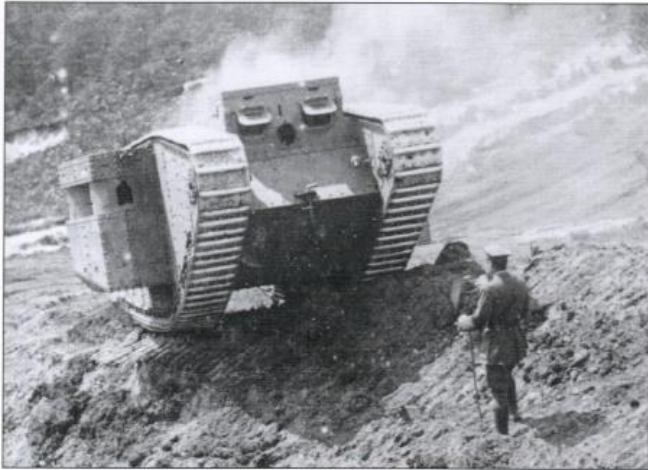
LEFT A Mark III Female with the old style sponsons training at Bovington. Glancing at the cab front one can see the round hole for a Lewis gun and the way the vision slits have been raised to a point just below the lip of the cab roof. These are two key identification features of the Mark III.

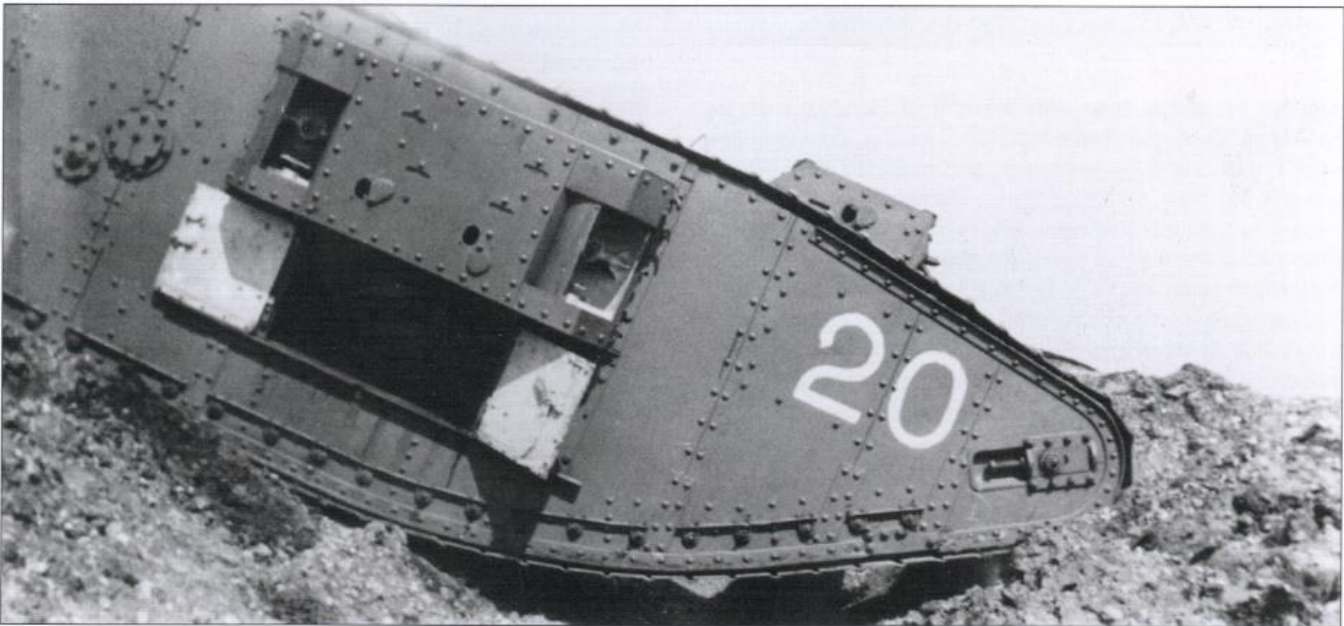
BELOW An excellent view of a Mark III Female with the smaller Lewis gun sponson. The escape hatches below the sponson are wide open and the two rotating shields for the machine guns have been turned to face inwards. Notice also the clevises, or hooks, at each end of the sponson for lifting it off.

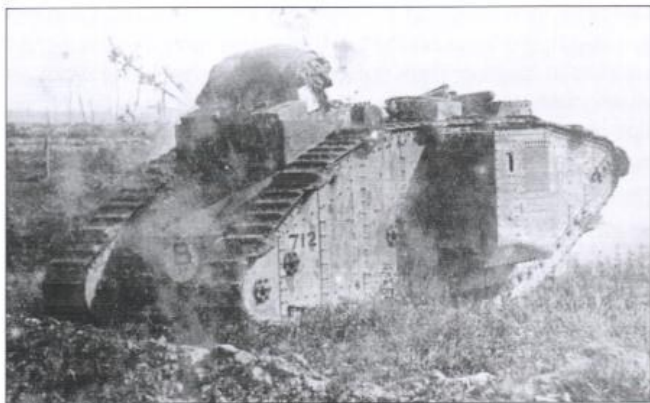
Fully stowed Mark I supply tank moving up at Messines. There is a stowage box between the rear horns, another on top and more stores simply dumped on the roof. Notice how the gun position has been filled in and that this tank is fitted with track extenders.
