US Navy Aircraft Carriers 1922–45

Prewar classes

New Vanguard • 114

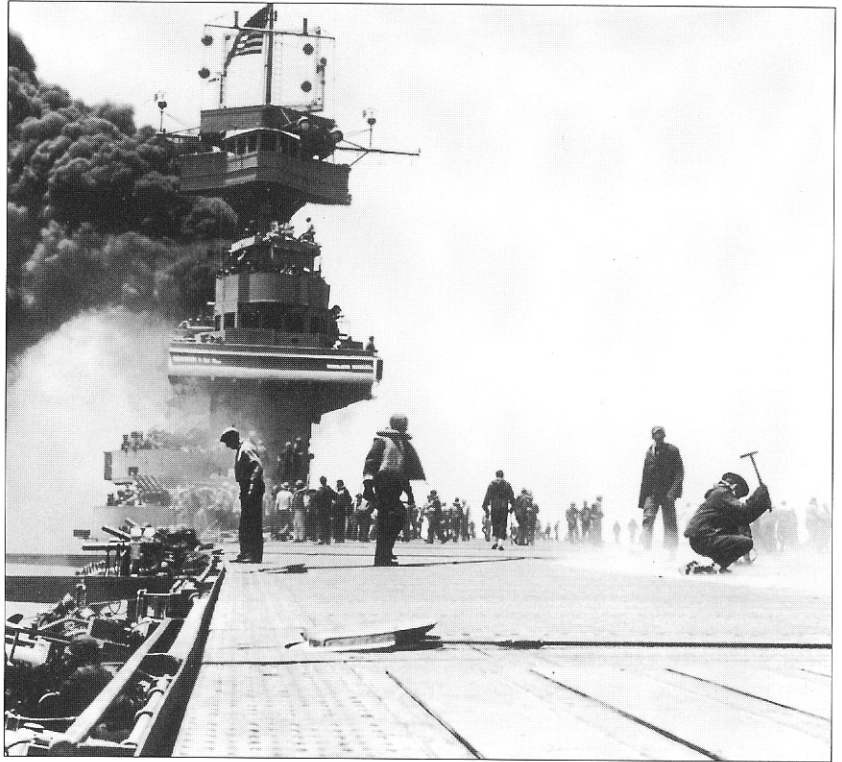
The US Navy's prewar fears of the vulnerability of its carriers was largely accurate during at least the first year of the war. This photo shows the effect of a Japanese divebombing attack on *Yorktown* at Midway. A 550lb bomb penetrated the flight deck and exploded inside the stack uptakes with the result being the intense black smoke seen here.

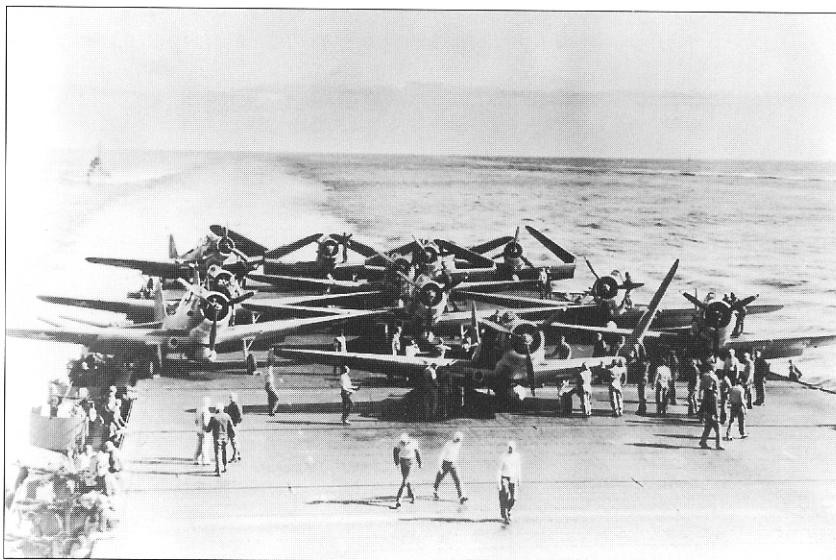
Enterprise's torpedo squadron (VT-6) shown spotted on the flight deck on June 4, 1942. Of the squadron's 14 aircraft sent against the Japanese carrier force at Midway, only four survived. This was the Devastator's final combat operation.

In 1937, torpedo squadrons received their first monoplane torpedo aircraft, the Douglas TBD Devastator. For its day, it was a modern aircraft, but by 1941 it was already obsolescent. Five squadrons were in service at the beginning of the war: VT-2, 3, 5, 6, and 8. The Devastator's replacement, the Grumman TBF, was already on order, and after the disastrous performance of the Devastator at Midway, all remaining aircraft were retired from combat service.

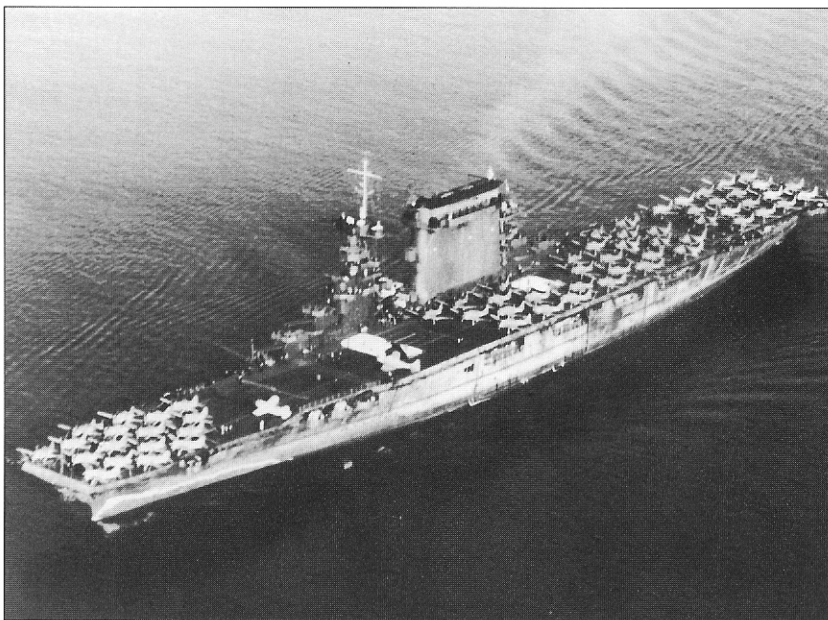
Lexington on October 14, 1941 with her air group. She is carrying F2A Buffalo fighters forward, SBD Dauntlesses amidships, and TBD-1 Devastators aft. The ship is wearing a Measure 1 camouflage scheme with a Measure 5 false bow wave.

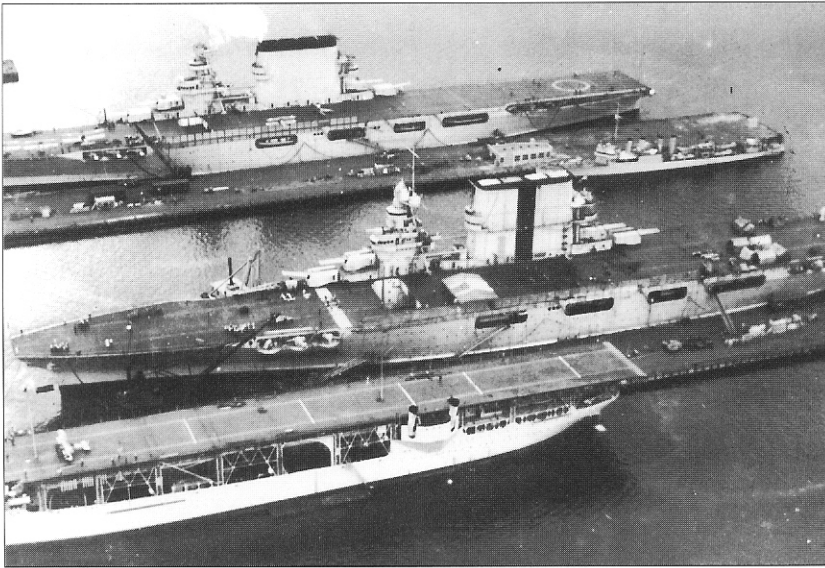
The US Navy's first three carriers shown c.1930 in Bremerton, Washington. The immense size of the converted battle cruisers *Lexington* and *Saratoga* compared to the experimental *Langley* is striking.

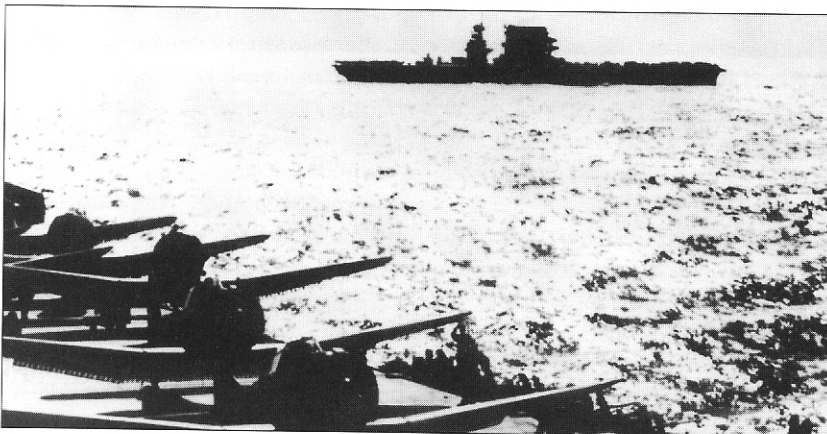
***Lexington* viewed from *Yorktown* on May 8, 1942, the day the two US carriers engaged in history's first carrier battle. The four 8in gunhouses have been removed and replaced with light anti-aircraft weapons.**

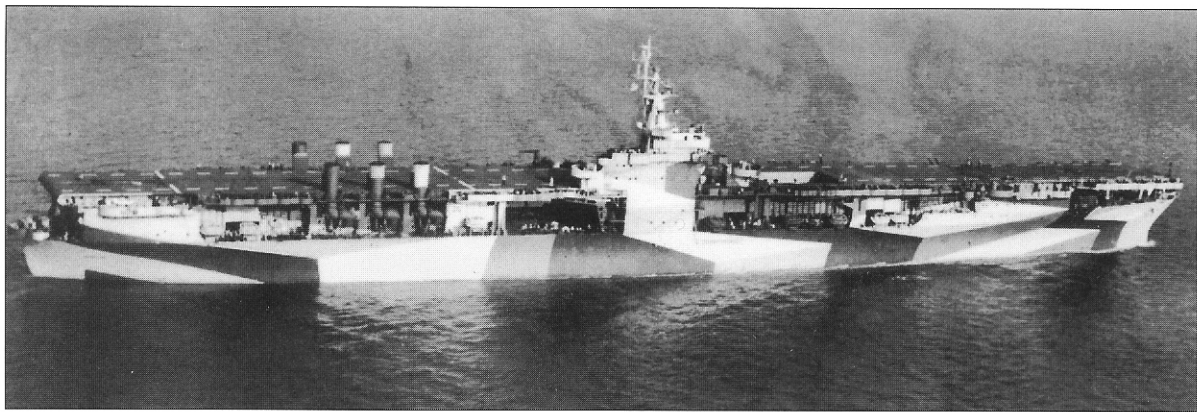
Ranger shown on July 6, 1944 in a Measure 33/Design 1a camouflage scheme. Despite the profusion of antiaircraft weaponry and the addition of radar, the ship was never committed to a high-threat area and by this time had already assumed the role of a training carrier.

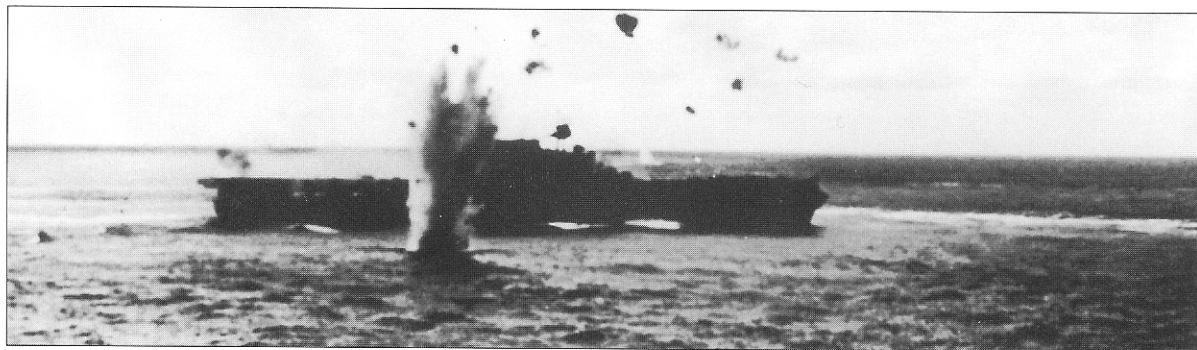
Enterprise under attack at Santa Cruz. Hit by two bombs, 44 of her crew were killed and 75 wounded.

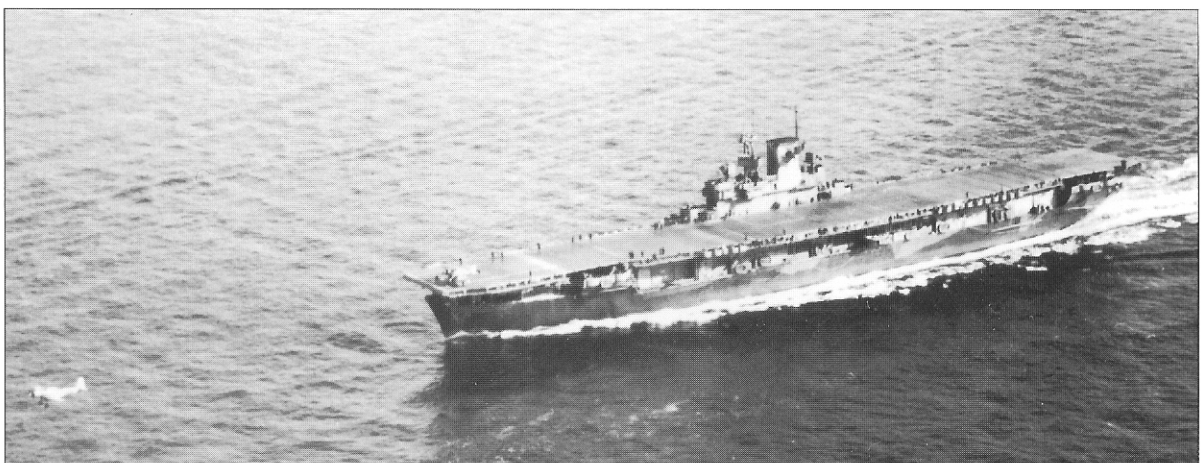
Wasp shown in March 1942 in her Measure 12 (modified) scheme; she would retain this camouflage until her loss. The aircraft spotted forward is a Grumman J2F utility aircraft.

During her short service life, little was done to *Wasp* other than to enhance her antiaircraft protection. By January 1942, this had been increased by 34 20mm guns with all but six of the machine guns having been removed. The 5in battery and the 1.1in mounts were retained and their splinter protection improved. As with other carriers, it was intended to rearm her with 40mm and 20mm guns, but only a single quadruple 40mm mount was fitted before her loss. During a January 1942 refit, a CXAM-1 radar was fitted.

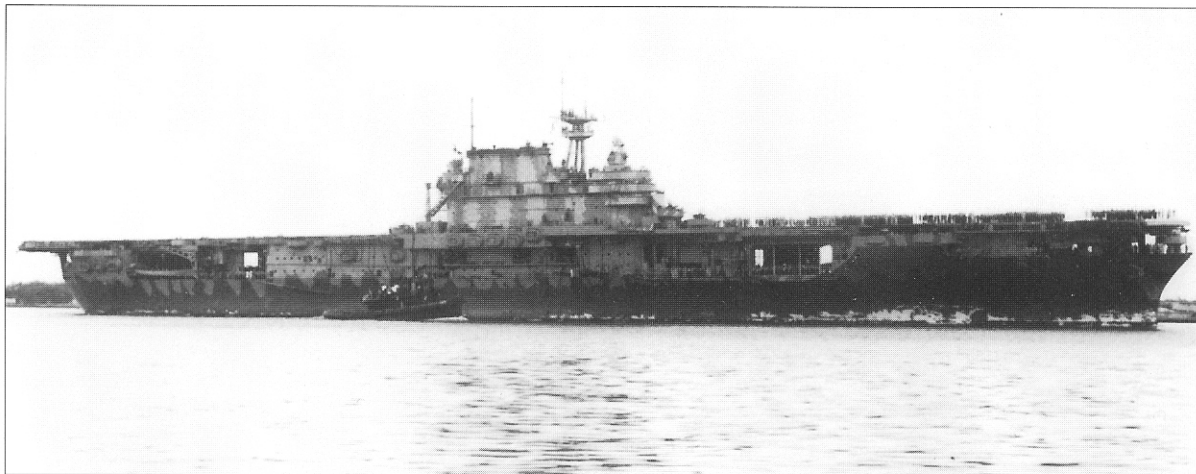
Hornet entering Pearl Harbor May 1942. Extensive wear on her Measure 12 scheme is evident.

Measure 12. This scheme was employed from September 1941 until late 1942/early 1943 and was worn by all prewar carriers except *Saratoga* and *Enterprise*. It was a graded scheme using Sea Blue 5-S from the waterline to the hangar deck level, Ocean Gray 5-O on all other vertical surfaces, and Haze Gray 5-H used on all masts. Decks were painted in Deck Blue 20-B. *Ranger*, *Wasp*, and *Hornet* were painted in Measure 12 (modified), which applied the Sea Blue in a pattern that varied on each ship. Measure 12 was considered to be effective in its purpose of providing concealment against both surface and aerial observation while also providing some course and range deception.
