# SOVIET HEAVY TANKS

Steven J. Zaloga and James Grandsen

VANGUARD SERIES

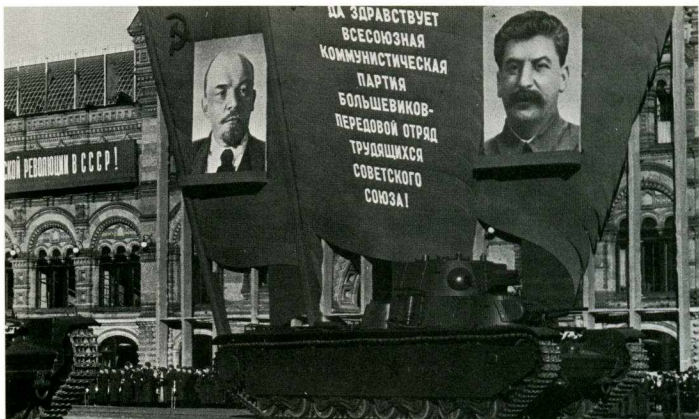
The last of the multi-turreted behemoths built for the Red Army, the T-35 Model 1938 differed from earlier models in having sloped turret armour for slightly better ballistic protection. Here tanks of the 34th Tank Div. parade in Red Square on 7 November 1940. (Sovfoto)

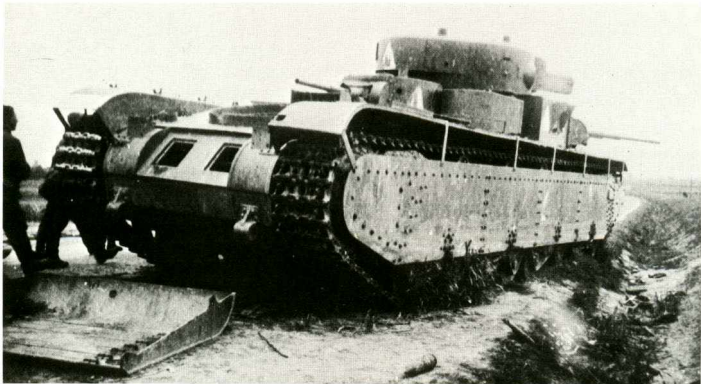
**The combat career of the T-35 was brief and unremarkable. Most of the multi-turreted battleships fell victim to their own mechanical unreliability, and were abandoned during the calamitous frontier battles of June 1941 in the Ukraine, like this T-35 Mod.1935. The engine cover has been removed in a vain attempt to repair it. The significance of the hastily-painted white triangles on hull and turrets is unknown. (James Crow)**

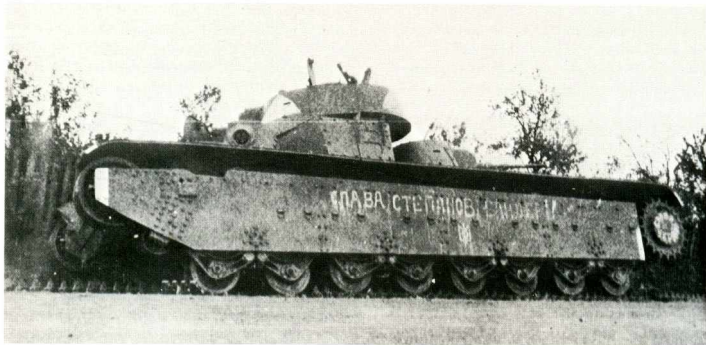
This T-35 Mod.1938 apparently served the Ukrainian nationalist cause for a short time in late summer 1941 before being abandoned near Lvov in October. The slogan is 'Glory to Stepan Bandera', referring to the leader of the Ukrainian OUN movement, and below it is the 'trident of Volodymyr' emblem; round the drive sprocket is painted 'Glory to the Ukraine'. (James Crow)

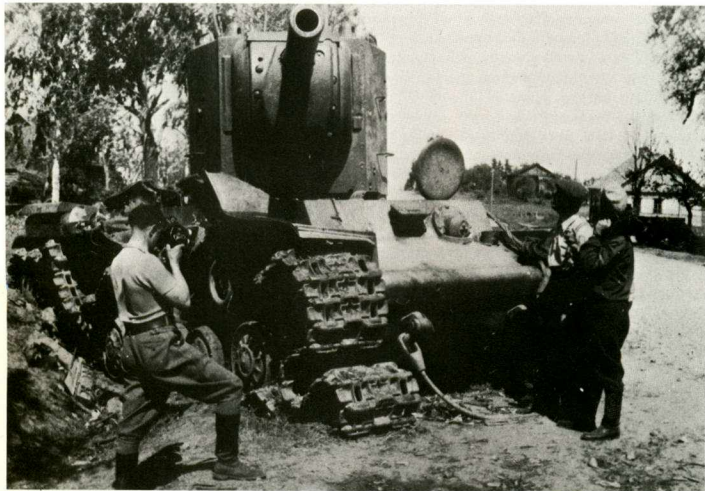
**Axis cameramen recording close-ups of the KV-2 at Rasyevnia after its eventual capture.**

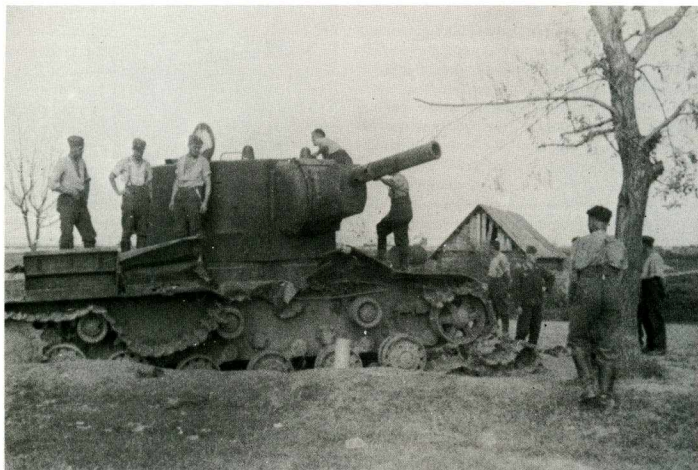
**This lone KV-2 Mod. 1940 of the 2nd Tank Div. held off repeated attacks by 6th Panzer Div. near the Rasyeinyia cross-roads in Lithuania. The damage caused by the engineer demolition charges on the right track is evident here. (James Crow)**

gun was only 600 yards away when it began firing and was soon joined by the others. The KV-2 was not in the least disturbed by a direct hit, nor by the six other rounds that struck in quick succession. It destroyed the first gun with a direct hit, followed by several more rounds that damaged the other guns. In the meantime an 88mm Flak gun from Flak. Abt. 298 was carefully pulled out of its emplacement near Rasyeinyia and camouflaged with branches. The half-track towing it moved carefully behind the wrecked trucks for concealment and the crew hastily lowered the gun off its limbers. The activity had been spotted by the KV, and when the '88' was only 900 metres away the Russian gunner destroyed it and the tractor with two direct hits. Relief parties were kept away by machine gun fire. That night a squad from Pz.Pioniere Bn.57 crept up to the KV, placed a double charge of explosive against the hull, and detonated it—only

to duck as the KV began spraying the area with machine gun fire. A straggler from the team approached the vehicle and found that the charge had only broken the track and ripped up the fender without any effect on the armour. He placed a second small charge on the barrel, but this had negligible results.

Freed of the threat from the north, a platoon of PzKpfw 35(t)s was dispatched the next day from the bridgehead and worked its way to a small wood near the lone KV-2 at the crossroads. They kept up a steady stream of fire to distract the Russian crew while another 88mm gun was carefully brought up from Rasyeynia. When in position it opened fire, scoring six direct hits. The tank crews dismounted to inspect the KV, which had not even burned. On reaching the tank they were appalled to notice that only two of the six 88mm rounds had penetrated the armour. There were seven small gouges from the 50mm strikes, but there was no damage evident from their 37mm guns. As a couple of the tankers climbed on board, the gun began moving towards them. An engineer who had accompanied them had the presence of mind to drop a couple of grenades through the holes in the turret rear, finally putting an end to this troublesome roadblock. This single KV had played a prominent rôle in delaying the advance of Panzergruppe 4 on Leningrad by forcing the diversion of the 1st Panzer Div. from its rapid drive to help out 6th Panzer, and prevented the destruction of the immobile 2nd Tank Division, if only for a day.

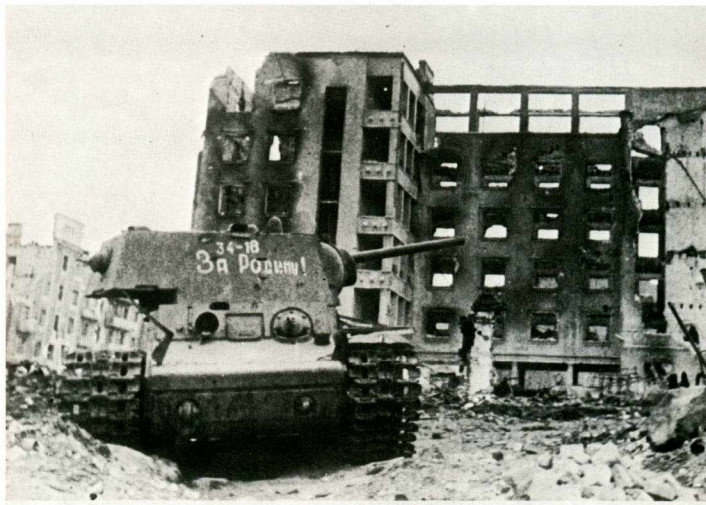
**One of the handful of KVs employed in Stalingrad, this Mod.1941 with the newer up-armoured turret is seen supposedly blasting German sniper positions; the turret marking is '34-18' above 'For the Homeland!' (Sovfoto)**

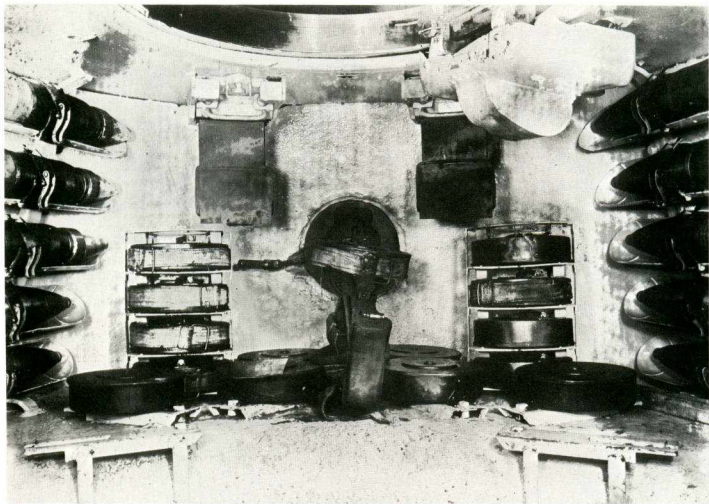
Rear turret interior of a KV-1 Mod.1941 (cast turret); note DT machine gun, DT drum stowage, and ten 76.2mm 'ready rounds'. The rear periscopes had canvas covers which were flipped up before use. (Ordnance Dept./National Archives)

The turret was arranged in the traditional, clumsy 1930s fashion, without a turret basket and with the commander doubling as the loader. This arrangement dated from earlier light tanks with two-man turrets, yet when three-man turrets were introduced the Russians used the additional crewman simply to operate the rear turret MG

used to keep infantry from swarming over the tank. This arrangement was not very efficient, as loading distracted the commander from his primary responsibility of directing the tank and issuing instructions to the driver and gunner. German tankers frequently commented that the Soviet tanks behaved in a very clumsy fashion, oblivious to local terrain features which could be exploited for better protection, and quite blind to many targets. Platoon-sized units showed little cohesion, and some stumbled about with little apparent regard for enemy tanks or the other tanks in their own unit. While some of these failings are attributable to poor training, much of the fault lies with the poor turret layout. This could not be remedied simply by having the third turret crewman, the assistant driver/

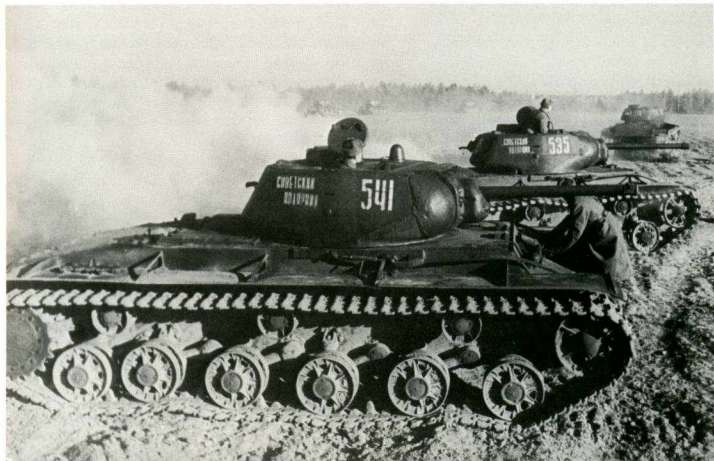
**KV-1S variants of a heavy tank regiment, presented in the name of a delegation from the Far North: the turret inscription is 'Sovetskikh Polyarnik', polyarnik being the term for Russians living in the Arctic regions. The KV-1S was a retrograde step in the tank's evolution, sacrificing armour for performance; note cupola, smaller and better-shaped turret and more sharply angled rear hull. (Sovfoto)**

A stopgap solution was the KV-1S (s: *skorostnyi* = speedy), a lightened version of the KV-1 Model 1942 of which 1,370 were built between August 1942 and April 1943. A smaller, thinner turret of better ballistic shape featured an improved layout, the commander being relieved of his rôle as loader and given an all-round vision cupola behind the gunner's station. Other changes were 75mm hull armour, reduced appliqué armour, light-weight wheels, a streamlined engine deck and new periscopes. The KV-1S was rushed to the new independent heavy tank regiments; some were also used by regular tank brigades, due to their improved speed. Among the first units so equipped were those earmarked for the Stalingrad counter-offensive; the best-known of these was the 121st Tank Bde. of the 62nd Army, later granted the title 27th Guards Tank Bde. for its performance in that campaign.

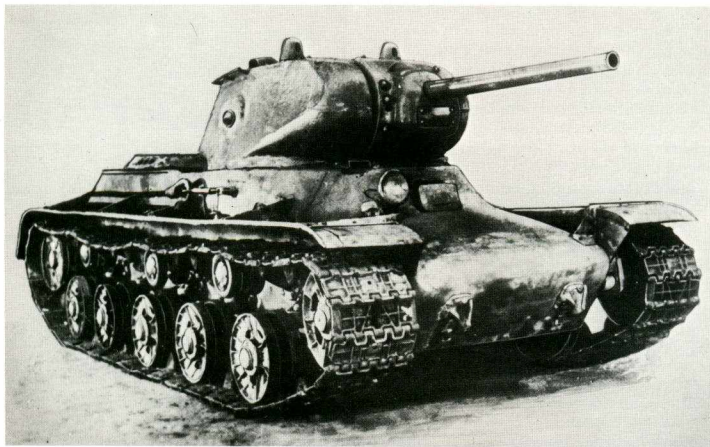
The KV-13T was one of a series of experimental designs which evaluated new heavy tank components; the hull armour layout later used on the IS-1 can be seen on this prototype.

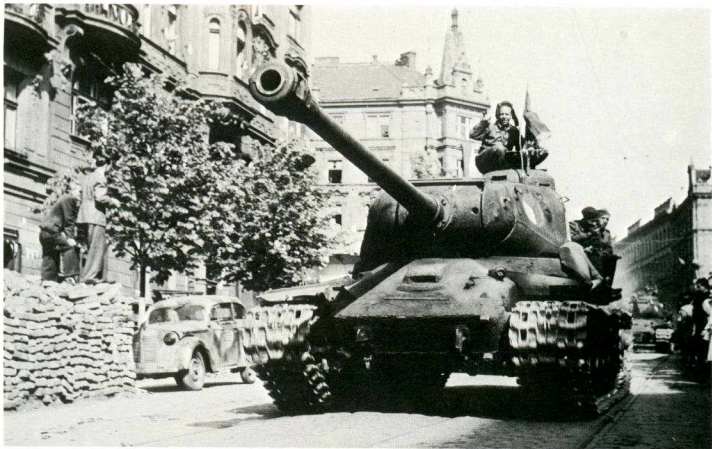
**Column of IS-2m tanks of the 1st Czechoslovakian Tank Bde. parade through the streets of liberated Prague in May 1945. The Czech roundel marking is clear in this view. (Czech Press Agency via J. Hornat)**

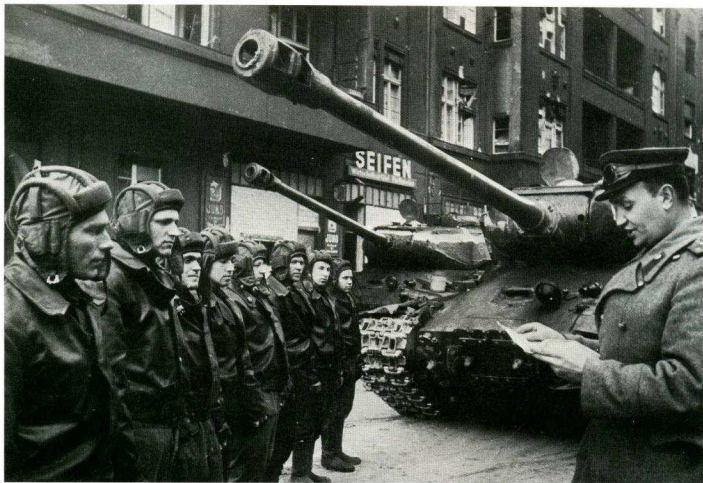
**IS-2m unit photographed in the streets of Berlin, 1 May 1945.** The crews appear to wear waist-length leather jackets and the black cloth summer-issue tank helmets over khaki overalls tucked into knee-boots. Note air recognition band on turret of further tank. (Sovfoto)

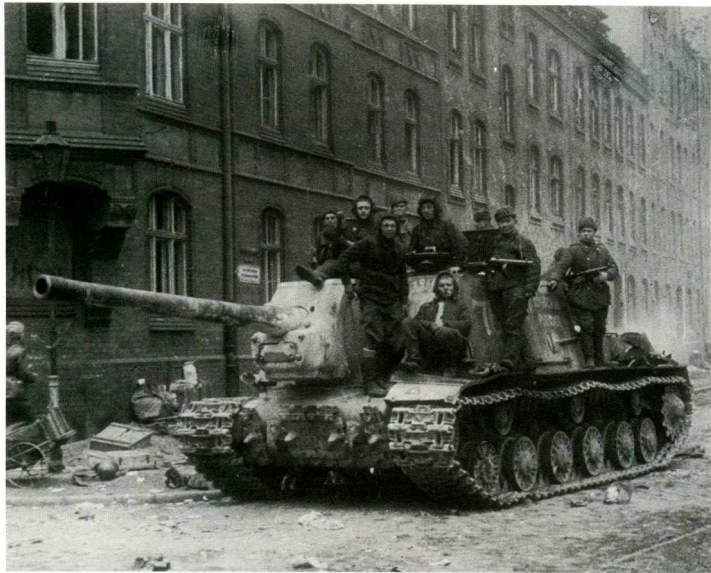
**ISU-122 in the streets of Gdansk in April 1945; the inscription behind the number '76' on the side is unfortunately indistinct. The ISU-122 and -152 were virtually identical apart from the gun, though the latter can be distinguished by its multi-baffle muzzle brake. The ISU-122S used the same brake as the IS-2 tank. (Sovfoto)**
